Excavations at Tell Timai 2012

University of Hawaii

December 1 to 27, 2012

APPENDIX II
SALVAGE EXCAVATION REPORT S10-1

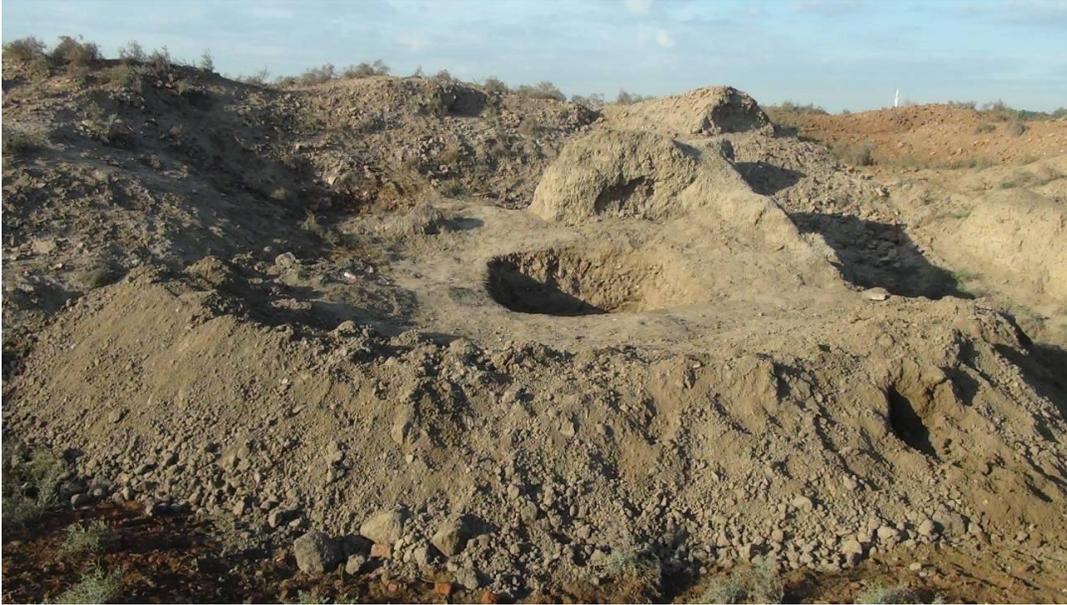
A 5-meter deep looter's pit in the central portion of Tell Timai.

1. Looting: During the course of this study approximately twenty new illegal excavation locations were identified with several excavations exceeding 5 meters in depth.

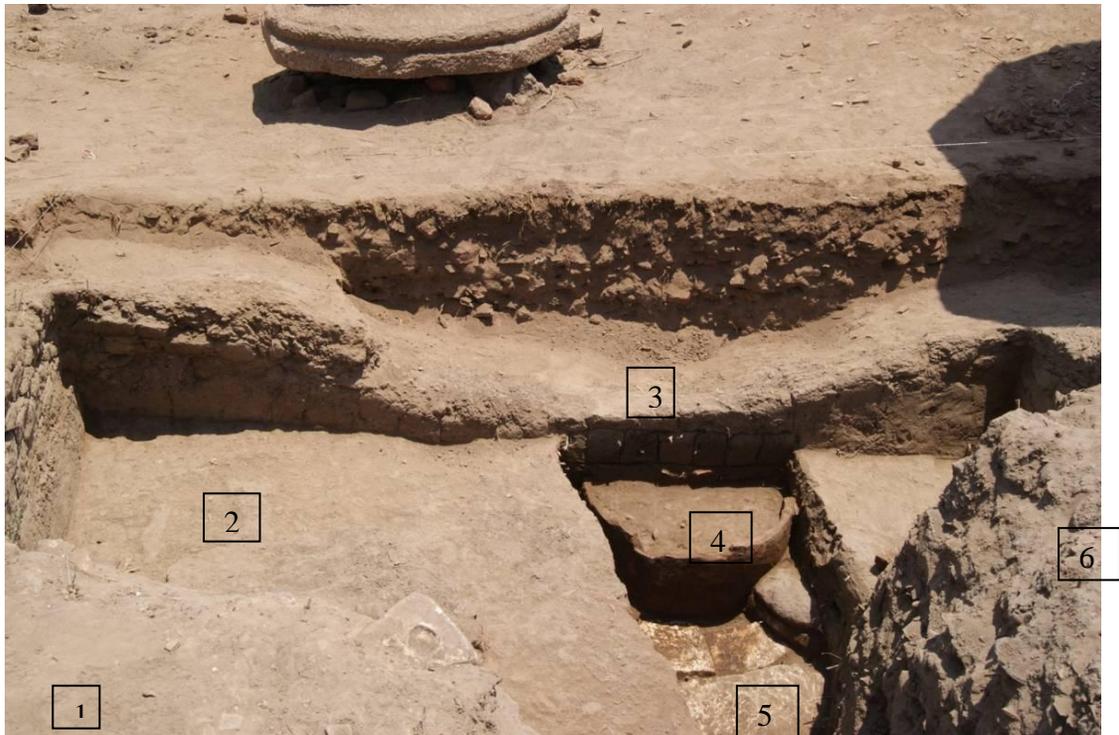
R13-2 in 2011 before closing the unit.

- 1- *Byzantine floor (destroyed by looters in 2012)*
- 2- *Early Roman floor (completely destroyed and excavated by looters)*
- 3- *Entrance to the byzantine structure.*
- 4- *Huge pot partly destroyed by looters and dated to the Late Hellenistic period.*
- 5- *Limestone foundation dated to the Late Hellenistic period (removed by looters).*
- 6- *Part of the byzantine floor.*

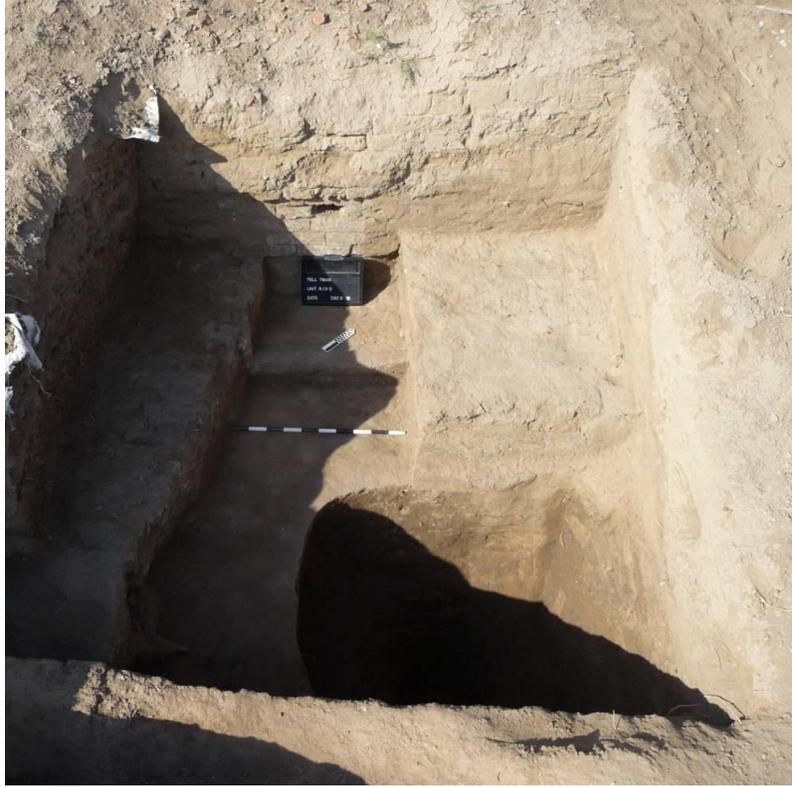
R13-2 after cleaning and removing the looters destruction.

After cleaning, four features were identified (R13-2-3266, -3267, -3278 and -3269). Excavations focused mostly on R13-2-3266 (Late Hellenistic layer) as it is the feature at the centre of the trench; this was also due to reduce the risk of collapse of the features that had been previously excavated, as the looters' hole reached a depth of at least 3 meters, Features R13-2- and R13-2-3268 were excavated partially for investigation--only pottery was recovered from these features.

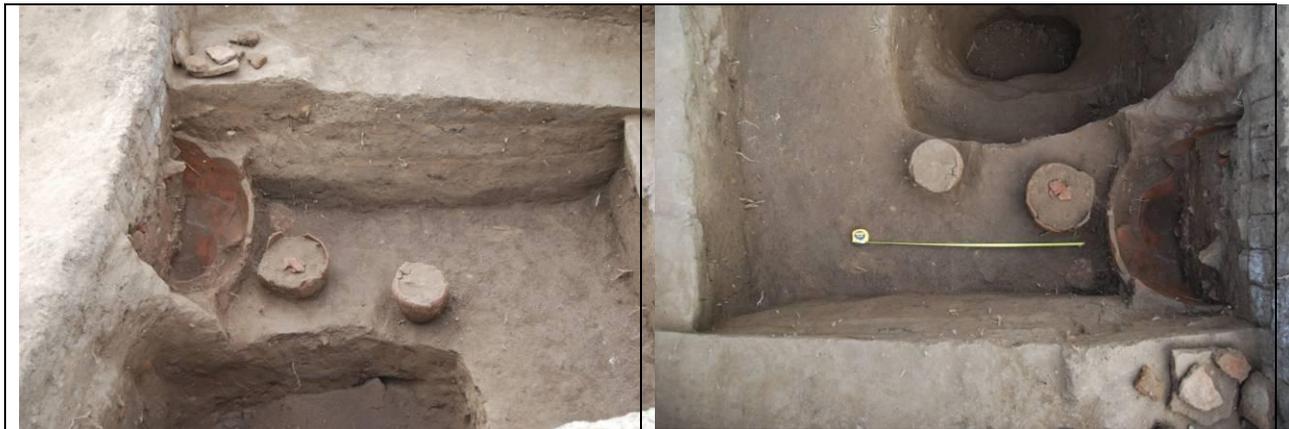
Pots *in situ* related to an early occupation dated to the Late – Middle Hellenistic Period.

Following the removal of R13-2-3266, a series of deposit layers were encountered (R13-2-3271, -3272, -3276 and -3277), differing in colour and typology of artifacts. Among the findings, the most interesting ones ranged from Ptolemaic coins and *in situ* ceramic pots, jars and bowls (R13-2-3271). This feature appears to be part of an earlier structure with a different function. The date appears Late Ptolemaic (pending analysis), but the whole structure was abandoned suddenly and does not show signs of destruction.

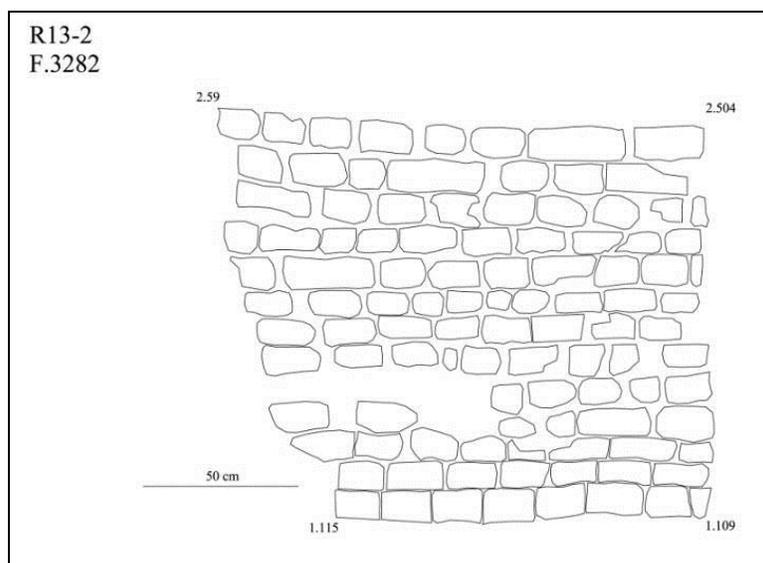
Fig.5: R13-2, simple drawing of one of the Hellenistic walls

As the excavations proceeded, two walls (R13-2-3282 and R13-2-3283) were recognized at the NE and SW edges of the area undergoing work inside the trench. Their discovery implies that the area had been re-utilized and the walls are connected to an early Hellenistic occupation. Although standing in close proximity, the walls do not appear to have any relationship between each other. This was confirmed during the finding of the floor R13-2-3280 (that lies between the two walls), the foundation of wall R13-2-3283 was below the floor associated at the foundation level of wall R13-2-3282. Moreover, wall F3283 does not continue beyond the limits of the trench, either terminating or curving in a NE direction (as opposed to wall R13-2-3282, which has a course following a SE-NW direction).

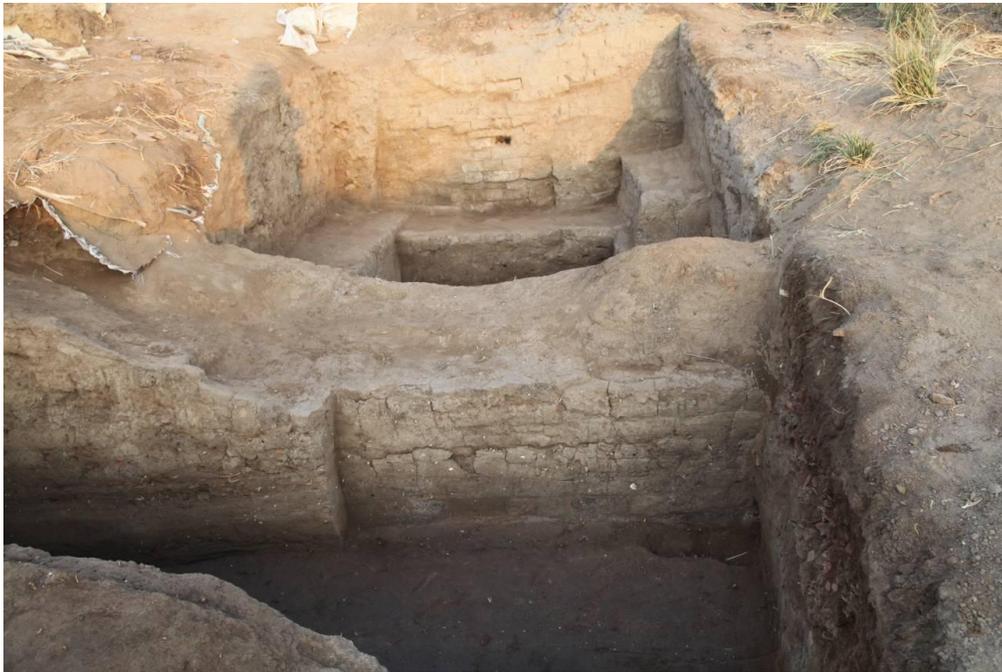
Unit R13-2 with extension (view northeast).

With the resumption of the excavations at the R13-2 unit it was decided to expand the unit in order to attain a better understanding of the context of associated features. A 3x4 meter extension was opened adjacent to the southeast edge of the original unit.

Two mud brick walls (R13-2-3278 and R13-2-3279) were uncovered soon after the surface layer was removed. The walls run parallel to each other at a regular distance of 1.50 m, but they do not seem to be contemporary as their foundations are lying at different levels. R13-2-3278 is built upon a thick layer of deposit, whereas R13-2-3279's foundations were not yet reached during the 2012 season. Moreover, R13-2-3279 was constructed alongside the walls R13-2-1320 and R13-2-1316, which enclosed the room of the original unit; it appears that R13-2-3279 is related to the room that had been excavated during the 2011 season.

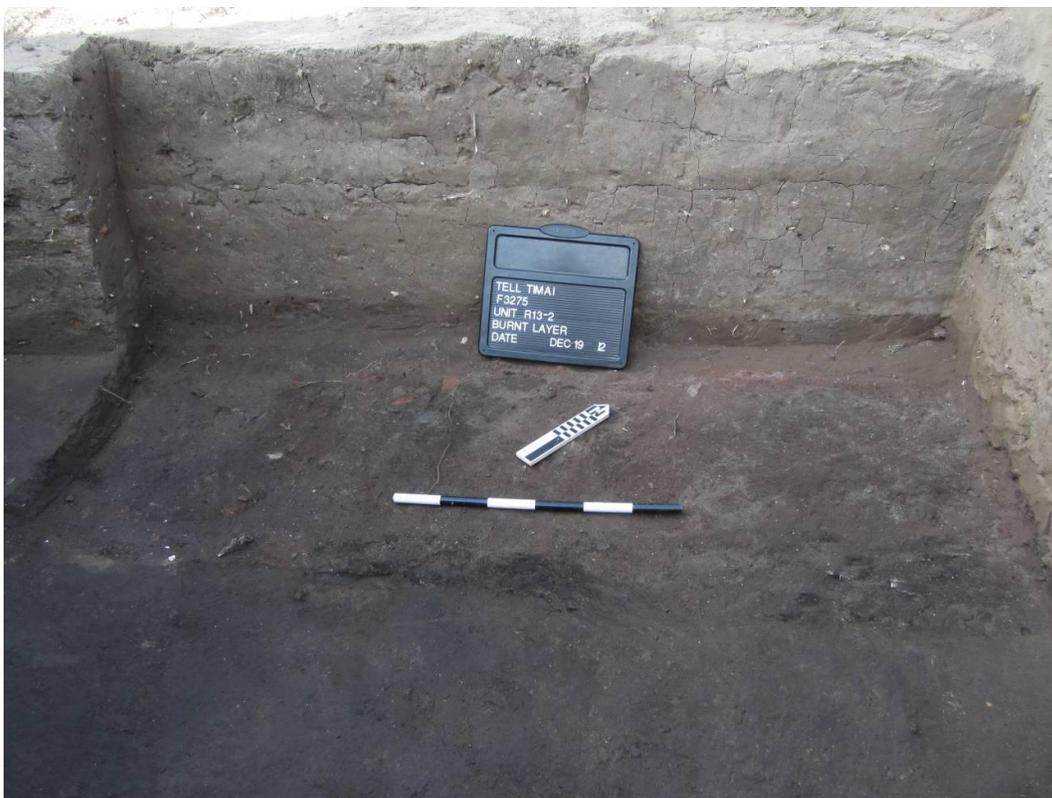
R13-2 showing the exposed burn layer.

By observing the stratigraphy, it was possible to detect the presence of a burn layer among the mud floor layers that comprised R13-2-3275. Upon the excavation of R13-2-3275, it was revealed that the burn layer extended over the entire area covered by the floor and appears to run beyond the limits of the unit. However, it is important to note that there is no other evidence of the burn layer on any of the other features inside the trench, particularly the walls and northeast profile of the unit. There are no indications of burning or of a burn layer inside the room to the north of the extension; therefore, the burning is confined to a long narrow area and to one particular feature. Its unique shape may have resulted from the cutting of the floor, which may have removed part of the burn layer. The burn layer may be considered to be a destruction layer, but given its size and extension it appears to have not been particularly destructive and occupancy and rebuilding occurred soon after it happened (the burnt layer in R13-2-3275 is the fifth of the six mud layers that make part of it). It is important to note, however, that although the phasing of the layer has not yet been precisely determined, it does appear to represent an event in the mid-Ptolemaic era and may correlate with the same event responsible for the more extensive destruction identified in the northern portion of the tell (Grids O4-P7).

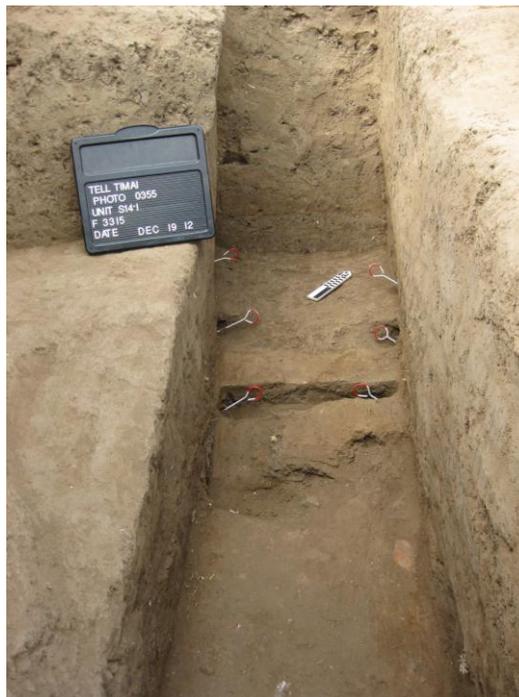
Stairway at the end of the corridor.

These structural elements combined to form a 2.5x3m room, with an entrance leading out to a small corridor, approximately 0.6m wide. The steps at the north end of this corridor appeared to climb up to the feature interpreted as a street in S14-2, the trench located immediately adjacent to the north. Flooring material located in the collapse layers and horizontal wooden postholes in the walls suggest the building had an upper story that collapsed into the lower room. Based on the nature of the *in-situ* finds, and the steps leading into it, the room has been initially interpreted as a storage cellar or similar located at the bottom of a larger structure.

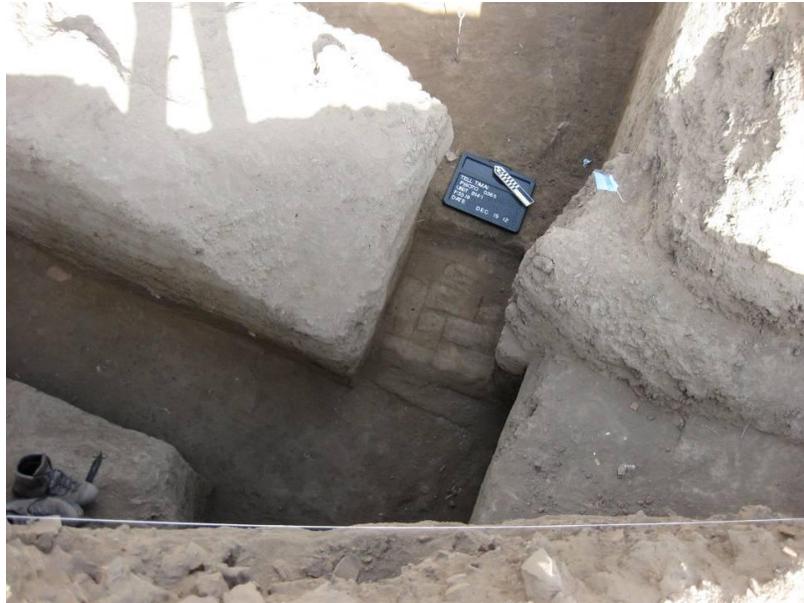
The doorway between room and corridor.

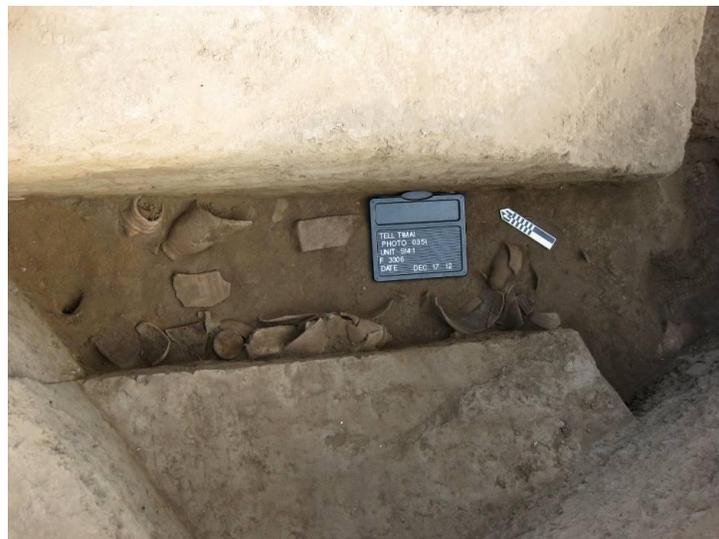
Ceramic storage vessels *in situ*.

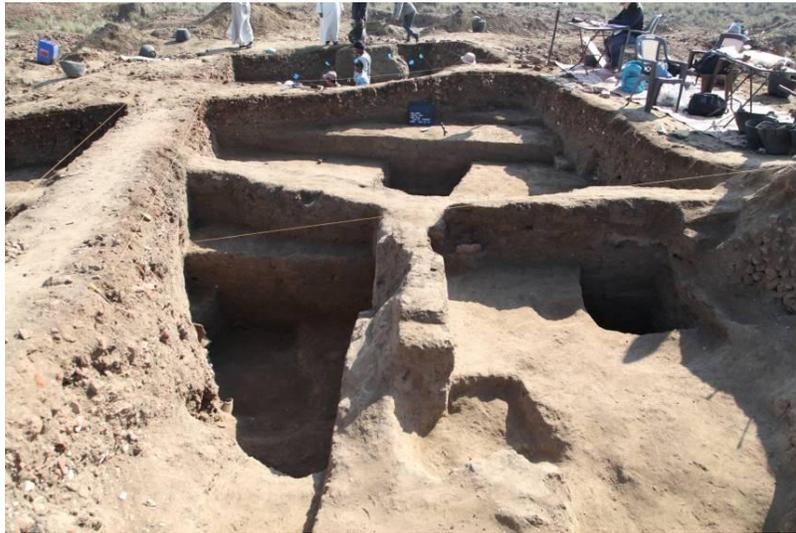
Units S14-2, S14-3, and S14-1 (view southeast)

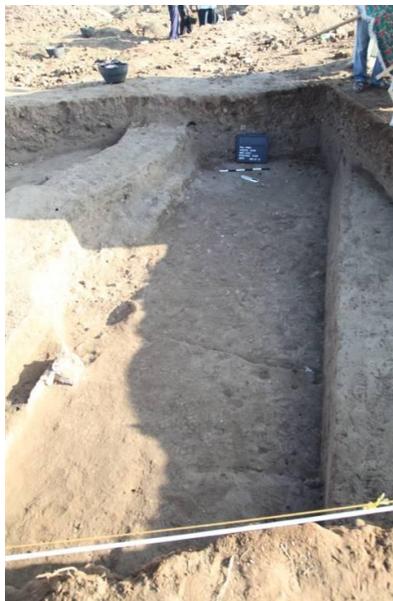
Passageway in S14-2.

A 1 meter-wide layer of compacted clayey silt covered by a thin (approximately 1 cm thick) layer of sand and plaster residue was uncovered. This compacted layer (designated Feature S14-2-3108) ran through the east side of S14-2 and into (but not all the way through) S13-4 at a north-south orientation. Directly to the east of Feature S14-2-3108 is a mudbrick wall and directly to the west the remains of a redbrick and plaster wall along with some mudbrick tumble. Feature S14-2-3108 was originally interpreted as a street or passage way between the exterior of buildings but may in fact be a corridor or open space within the interior of a building.

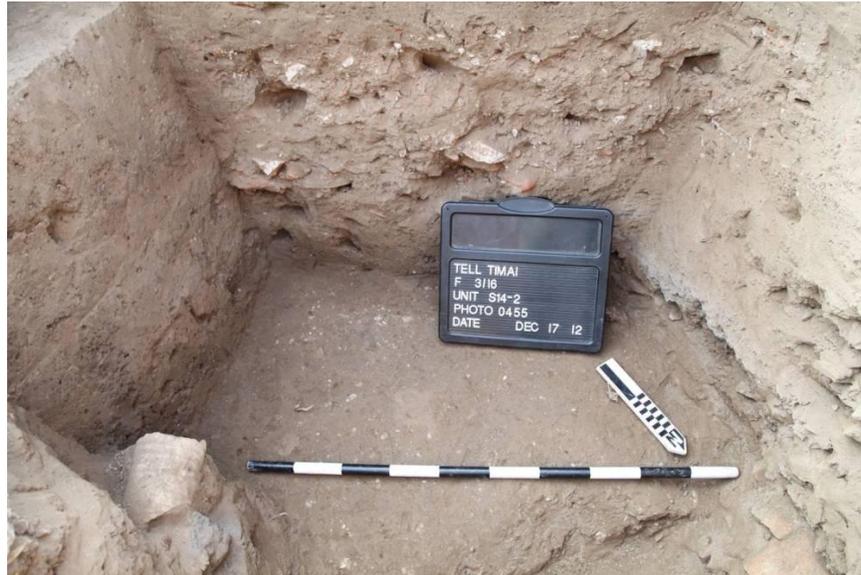
Floor in NW corner of S14-2 dated to Early Roman Period.

The room deposit in the northwest corner of S14-2 produced faïence and glass; utilitarian pottery, including amphora toes with small amounts of residue inside; and animal bones (sheep / goat, bovine, and fish, some of these bones had clear butcher marks); and frequent inclusions of charcoal. At 1.72 meters down the corner of a floor covered in plaster and pebbles was uncovered. At the same level of this floor under the west balk (same as Feature S14-2-3117) there was an Early Roman coin (possible Vespasian c. 69 AD, pending analysis).

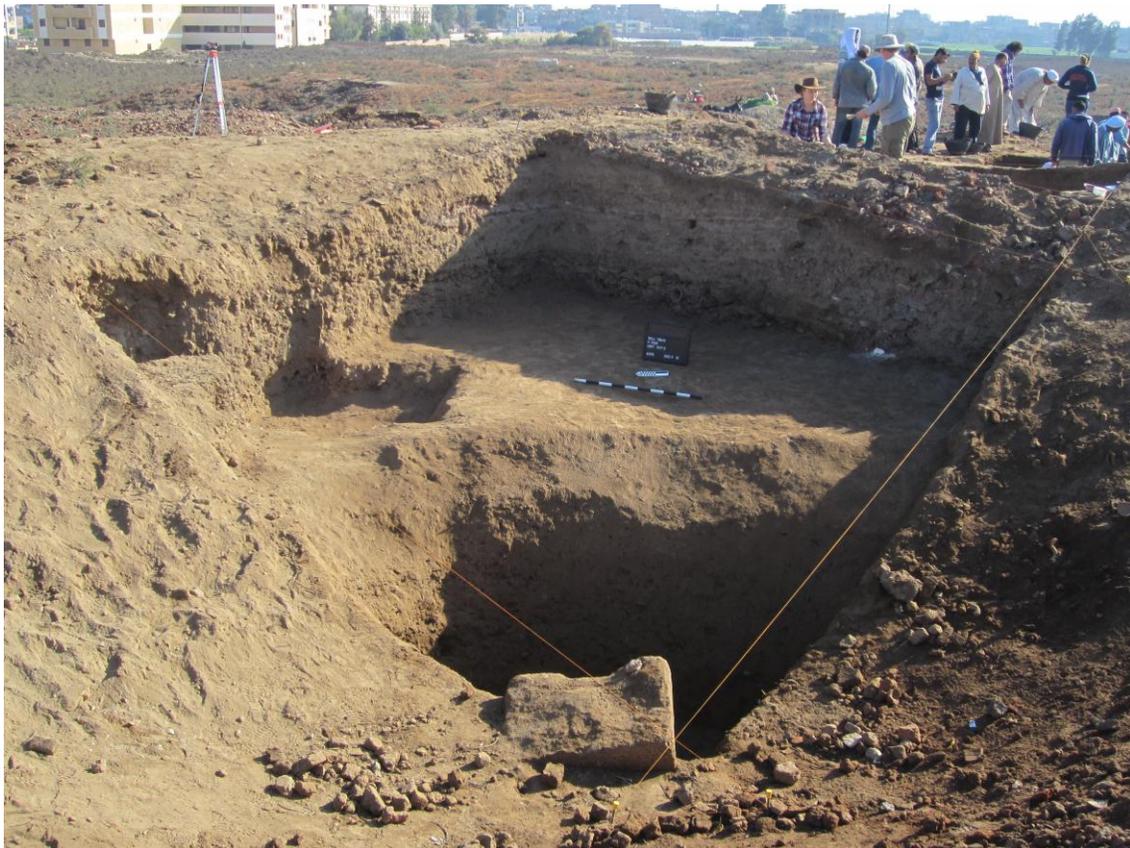
Unit S13-2 when closed (view southeast).

The bottom NW corner of the unit was excavated (S13-2-3200) in order to determine if the granite pillar was in situ or if it had purposefully been moved to the bottom of slope or if the pillar had fallen down. Initial excavations revealed slag, some pottery sherds and broken red-bricks. Two coins found in the unit, one on the surface layer (SCA#125) and one found in Feature S13-2-3201 (SCA#124) were able to be dated to 272/3 AD and 285/6 AD respectively. However, modern military debris was found in the central portion of the trench indicating that an explosion may have occurred in the location in the 1960s mixing and destroying contexts. The disturbed nature of the context would limit the quality of the data and resources were redirected to areas with less disturbance.

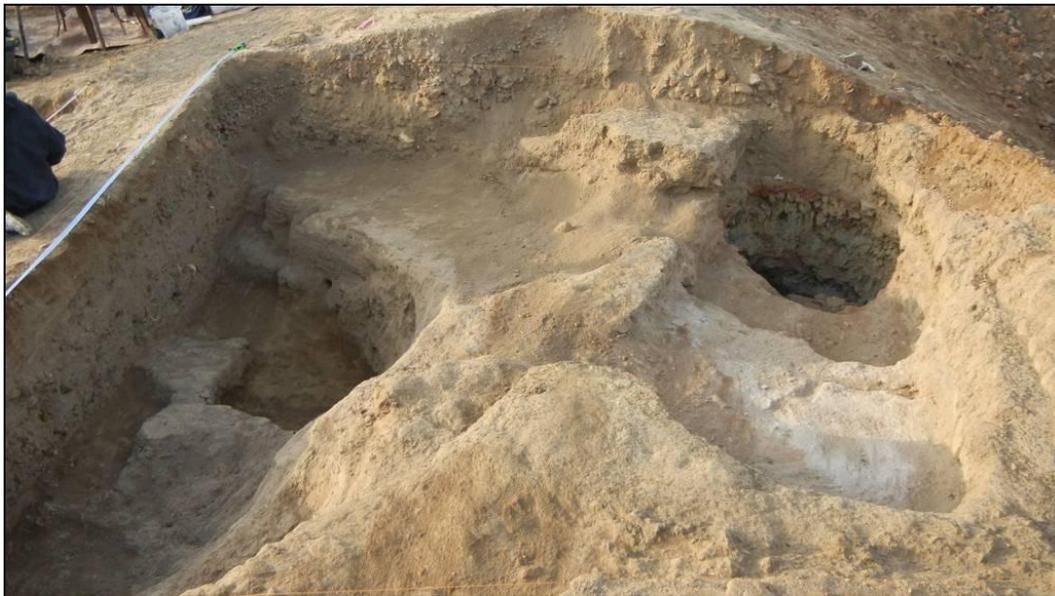
Photograph of the S13-3 showing the kiln in upper right corner (view northwest)

Unit S13-3 was opened during the 2012 season as one of five contiguous units to explore a segment of the central part of Tell Timai. It was one of four units that made a five by 23 meter, east-west trench (including three one-meter balks). Unit S13-3 was on the highest point of the terrain with S13-2 being on the west and S14-2 and S14-1 being on the east. The most interesting aspect of the unit is the kiln that was found in the southwest corner. It was made of red, baked bricks in a circular form and was about 12 courses high (1.15 meters deep). The courses were difficult to count because the kiln's purpose is not known at this time; speculations are that it was used for making either lime or faïence.

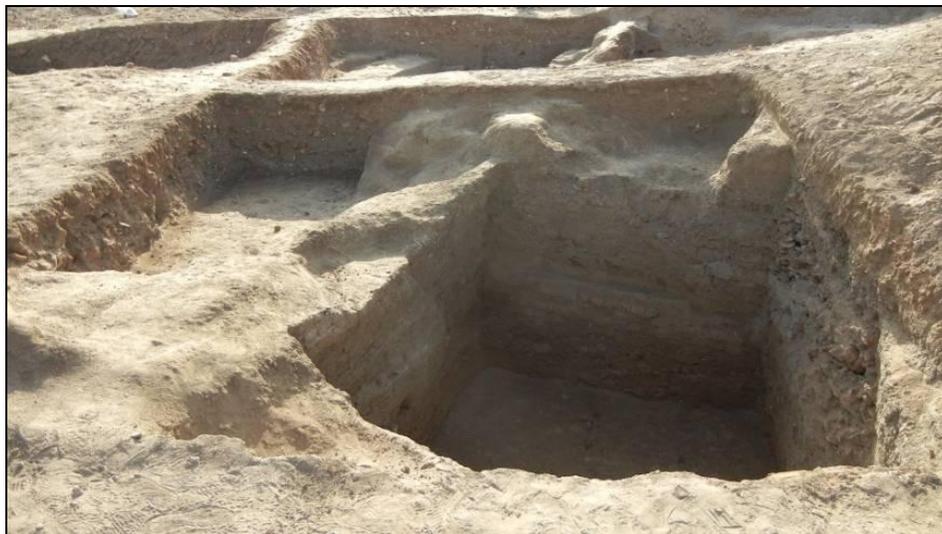
The flat portion in the upper left hand corner of the unit shows the roadway that continues from Unit S14-2, which is seen in the top portion of the photograph on the other side of a one-meter balk. The Roman room and Hellenistic structure below it are in the square on the right side of the photograph (view west).

The roadway in Unit S14-2 did extend into the southwest portion of Unit S13-4; however, the more informative portion of the unit occurred in the western side. A room was found that was approximately 3.12 meters square and that was aligned with a similar room in Unit S14-2. That room was partially excavated (the rest of the room was in the one-meter balk separating the two units). A portion of the southern and western walls of the room was in the west balk, but nearly all of the room was excavated. Even though a pottery analysis was not available at the time of this writing, excavated coins indicate that this room was Roman. The room had mudbrick walls that ran 12 courses of alternating rows of headers and stretchers. The typical brick was 25 cm long, 12 cm wide and 9 cm high. The room was filled with over one-meter of domestic and architectural debris (e.g., thousands of ceramic sherds and many baked red bricks and pieces of bricks with mortar bindings and plaster coatings). In the southwest corner of the room we found a small burn layer and many thick, coarse sherds from a ceramic oven.

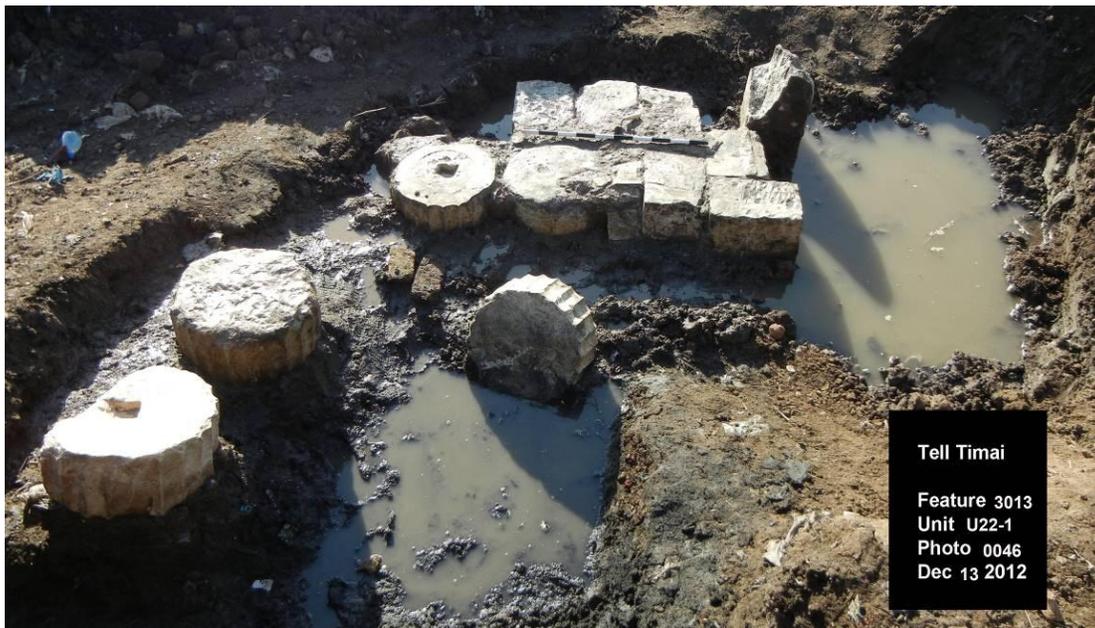
The stone platform in place after excavation (view south).

In the 2009 season along the canal in Grid U-22, several reused architectural blocks were found, one of which had a faint inscription of the cartouche of a Ptolemy as well as a number of Hellenistic columns, a portion of a ceiling, and a bas relief. In 2012, the area along the canal was revisited to ascertain if there were remains of an *in situ* Ptolemaic temple. A hydraulic bucket loader was used to dredge the modern garbage and fill at the north bank of the irrigation canal in Grid U22. Approximately two meters below the surface of the fill, the floor of a Roman period temple was discovered. 15 pieces limestone blocks were recovered, consisting of fluted column and rectangular blocks. The floor consisted of Ptolemaic limestone columns that had been reused, and made into a flat surface with the insertion of mortar and Roman brick to create a continuous base. Several column disks were discovered adjacent to the floor. Given the number of continuous limestone column disks recovered in 2009, and these additional disks, it seems probable that the reused disks served both as columns and part of the base of the Roman temple.

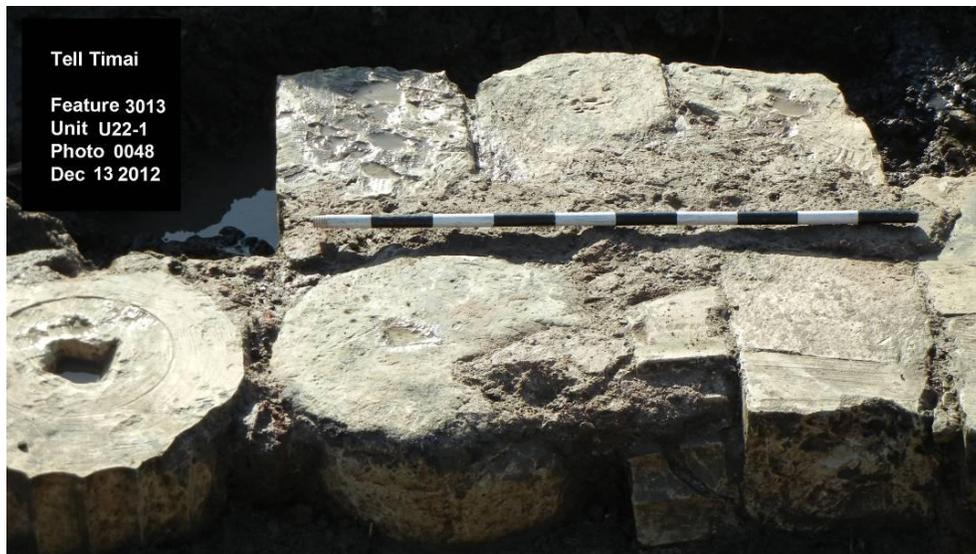
Hellenistic column disks reused in platform (view north).

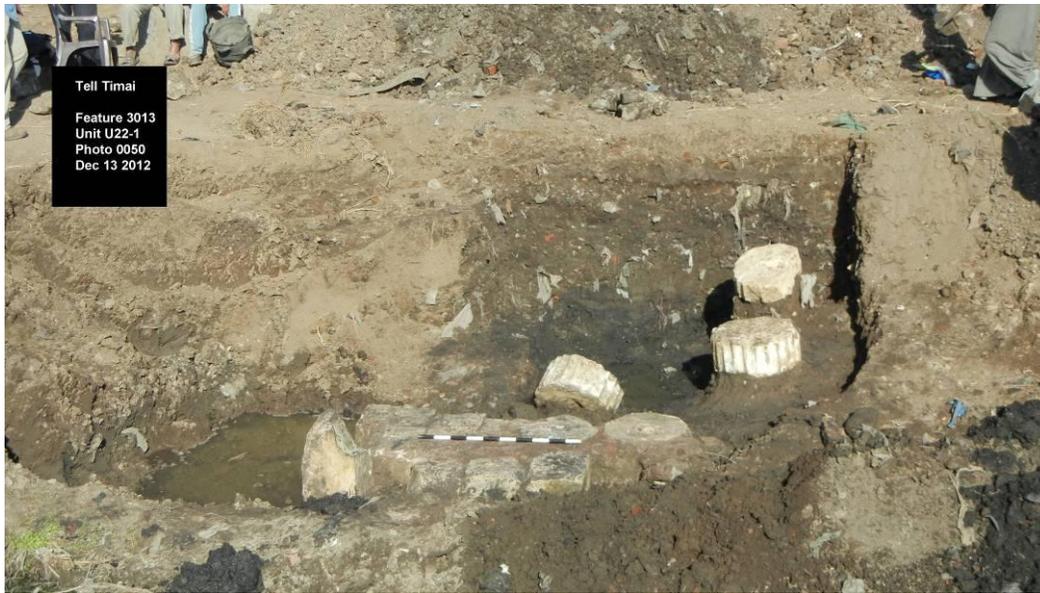
Unit U22-1 showing the profile with a thick layer of modern garbage fill on top of the cultural level (view Northeast).

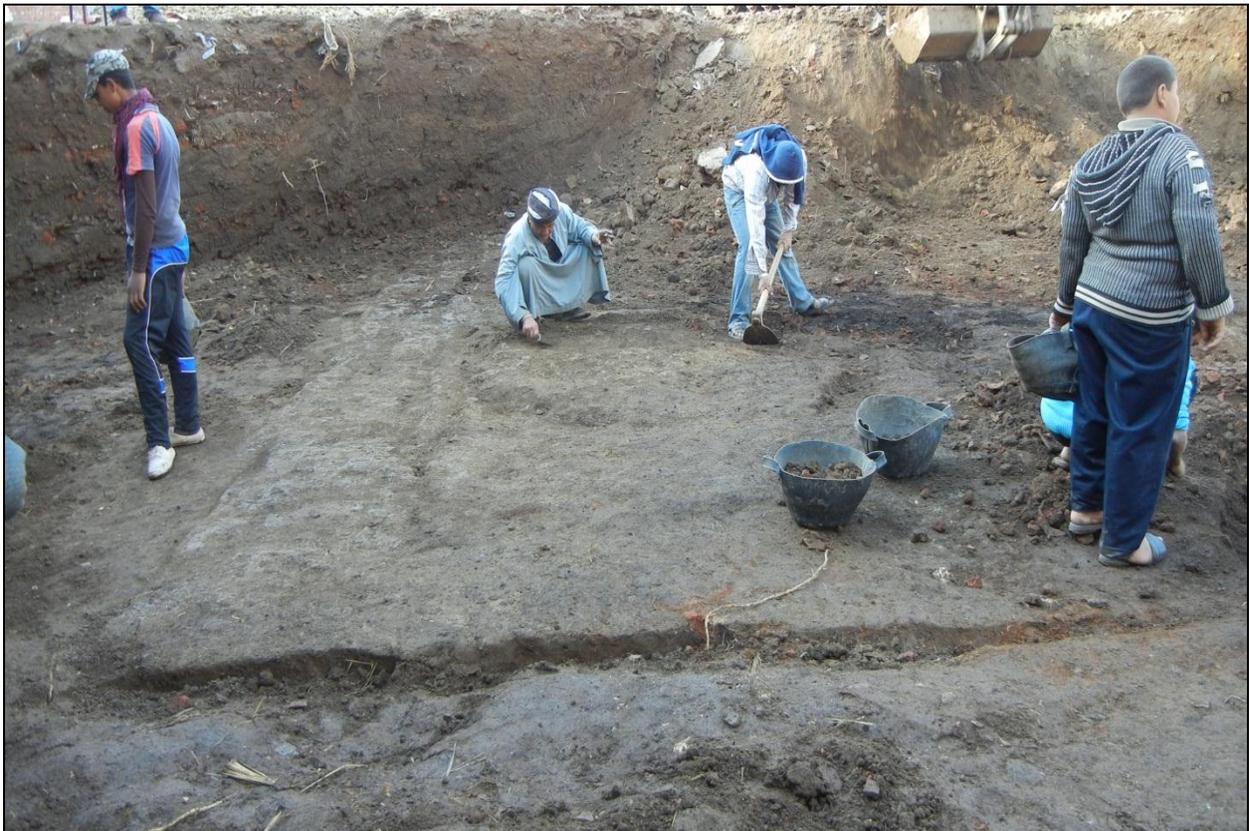
Figure 2. Clearing and cleaning the salvage area (view northwest).

While a mechanical front-end loader removed soil from the area down about three meters, the excavation team cleared and cleaned the remaining surface (see Figure 2).

This process revealed numerous features dating from the Early Hellenistic to the Early Roman Periods.

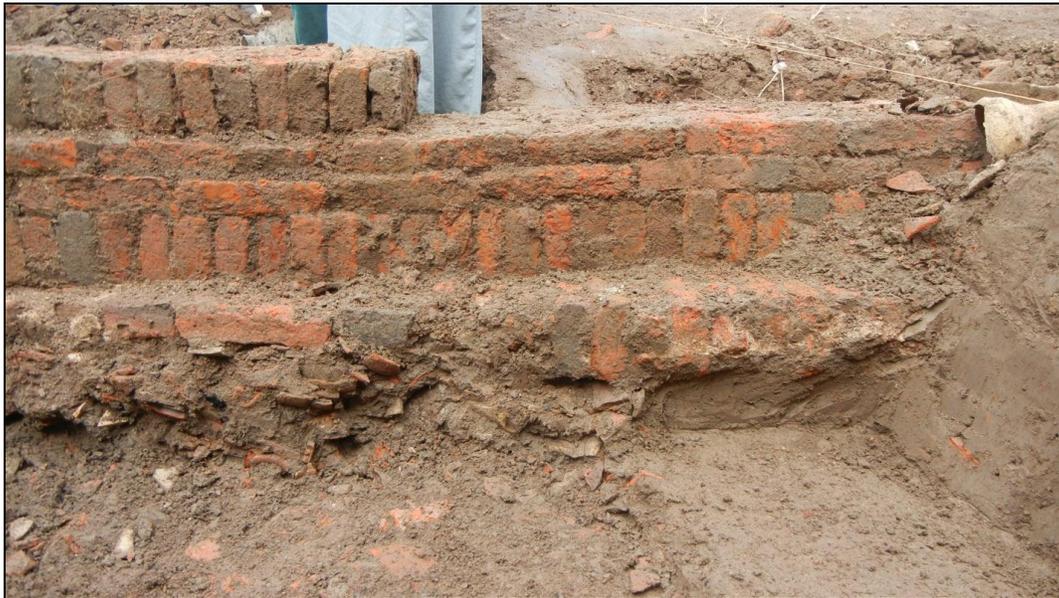
Figure 3. Coursings of the brick wall (view west).

1. The primary feature found was a red, baked brick wall that ran nearly the entire length of the eastern portion of the area (running from southwest to northeast). The wall is from five to three courses high. The middle of the wall is four courses with the top course being stretchers placed on edge and their flat sides facing each other. The next two courses are stretchers placed lengthwise on their flat surfaces. The bottom course is the same as the top course. These coursings are placed on top of a base that is either stretchers lying flat or on edge. (see Figure 3). The base is then covered with plaster (see Figure 4.).

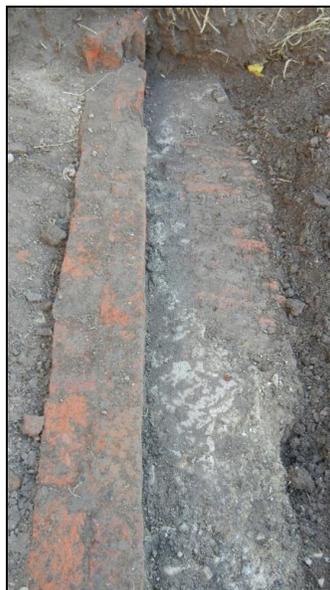
Figure 4. Base of brick wall covered with plaster. Photograph taken facing south.

The brick wall and base are believed to be a Roman or late Hellenistic aqueduct based on the presence of 1st century BC ceramics. The wall that probably was on the opposite side of the base and parallel to the existing wall is missing. However, SCA inspector Hamdy Mashal remembers that the SCA conducted an excavation of the same area about ten years ago. When the aqueduct was found then, it had a rounded brick top that allowed the water to be fully contained. This type of structure was known to exist, but its specific location was not known. The aqueduct appears to be an intrusive cut and construction within an earlier context.

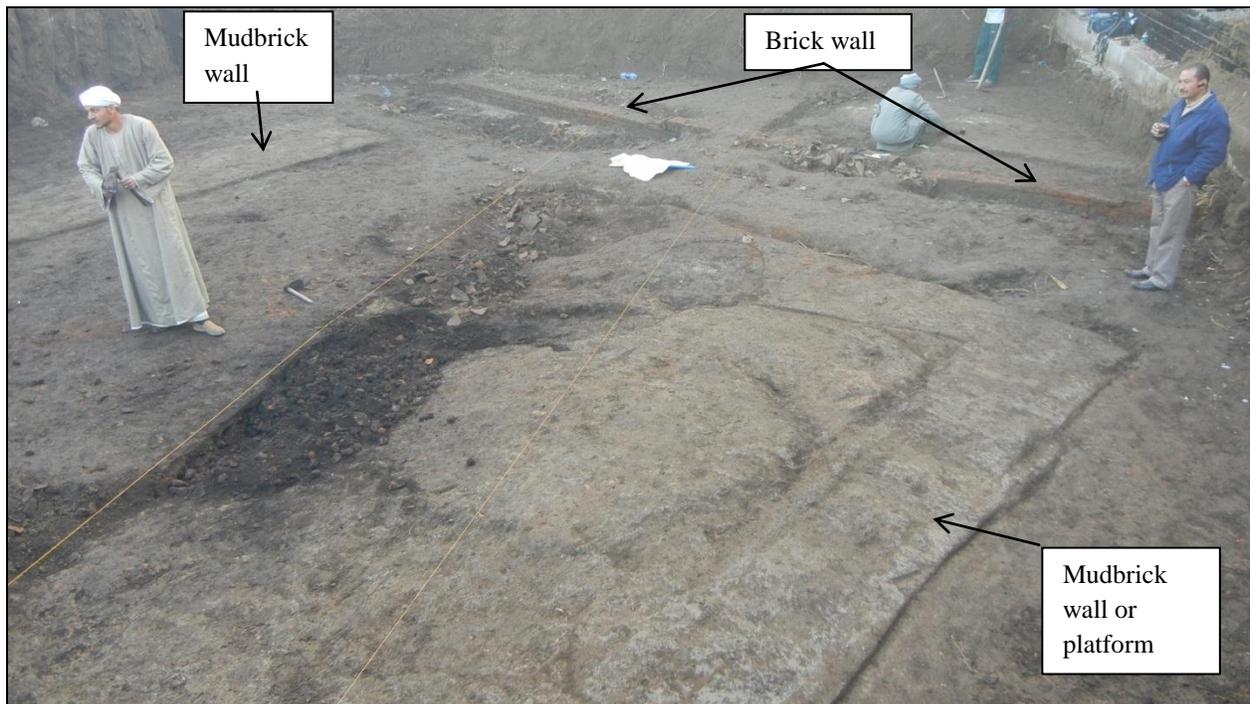
Figure 5. Mudbrick wall/platform and mudbrick wall (view east).

2. The second primary feature type that was found was mudbrick architecture. About one-third of the area was covered by a mudbrick wall that was flat on the east end and rounded on the west end. The area within the walls also looked like mudbrick, which could be either mudbrick fallen from the walls or the entire mudbrick area was a platform and not a wall. Running parallel to this mudbrick formation, but separate from it, was another mudbrick wall. (Figure 5) The purpose of the walls is unknown.

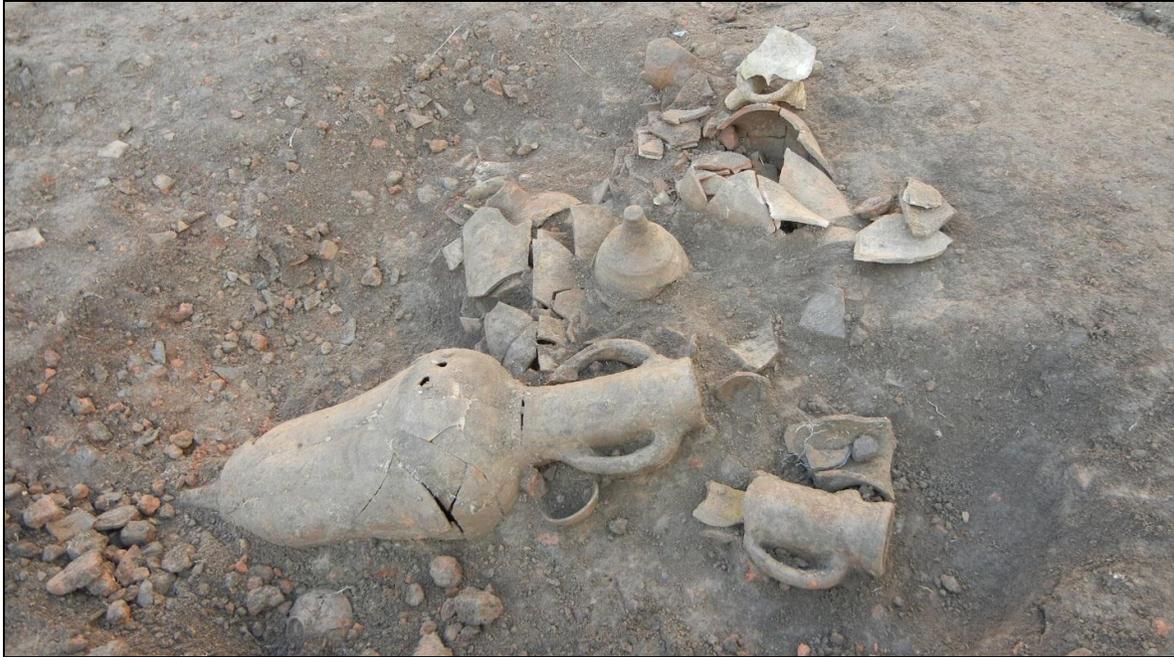
Figure 6. Complete, but cracked, AE3 (AE 3-2, Variant A, dating to 3rd-2nd century BC [Dixneuf 2011]) amphora (view north).

3. The third feature type found were deposits of amphorae. A complete, but cracked, amphora was found near the surface in a heap of ceramic sherds west of the brick wall (Figure 6). Three other amphorae were found broken in place along the west side of the brick wall (Figure 7). Even though a thorough analysis has not been completed on all of the pottery found in S10, the complete amphora has tentatively been analyzed by Dr. Mohamed Kenawi as being Hellenistic and dating to the 3rd to 2nd century BC (Figure 6).

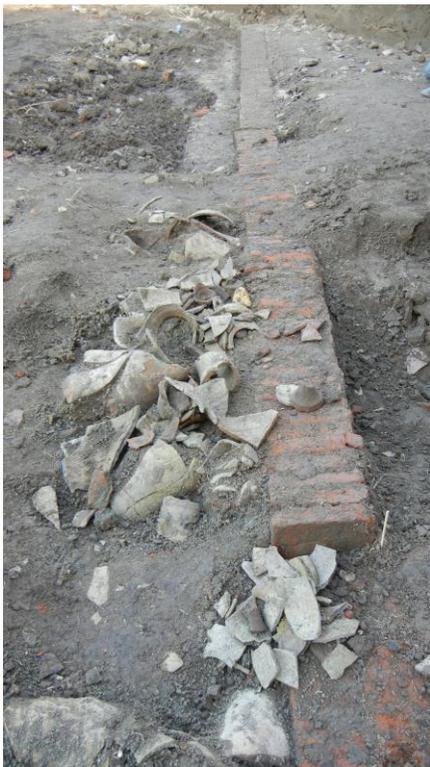
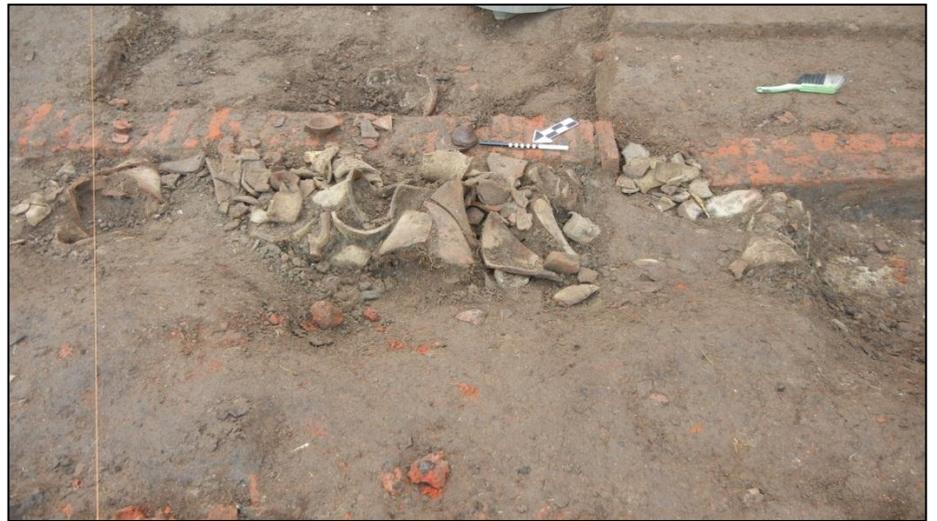
Figure 7. Four amphorae broken in place along brick wall (inside the aqueduct) identified as AE2, 1st century BC (views northeast on left and east on right).

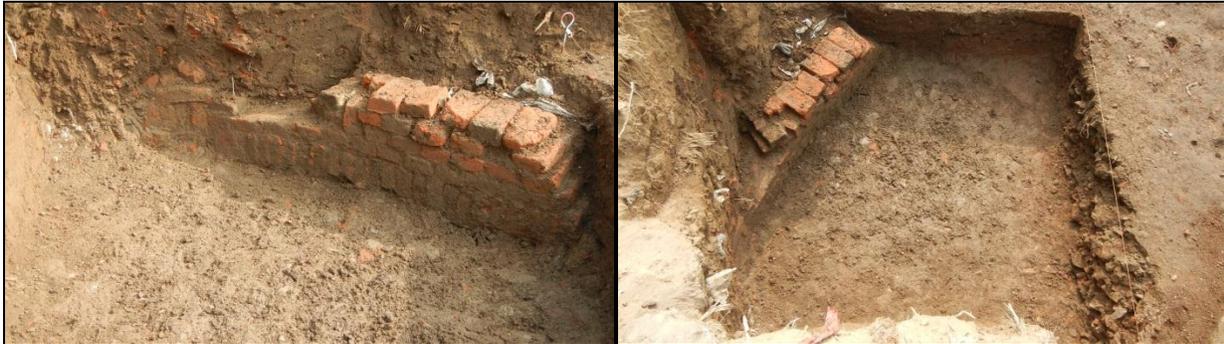
Figure 9. Brick wall found within the 2x2 meter test pit (view east on the left and south on the right).

Work in the test pit stopped after one meter because of a high water table that caused muddy soil. However, within the pit was found a possible continuation of the brick (aqueduct) wall. Except, the brick wall that was found would have been part of the west side of the aqueduct, which was not found within the larger area. Also, the wall branched to the north in the balk (Figure 10).

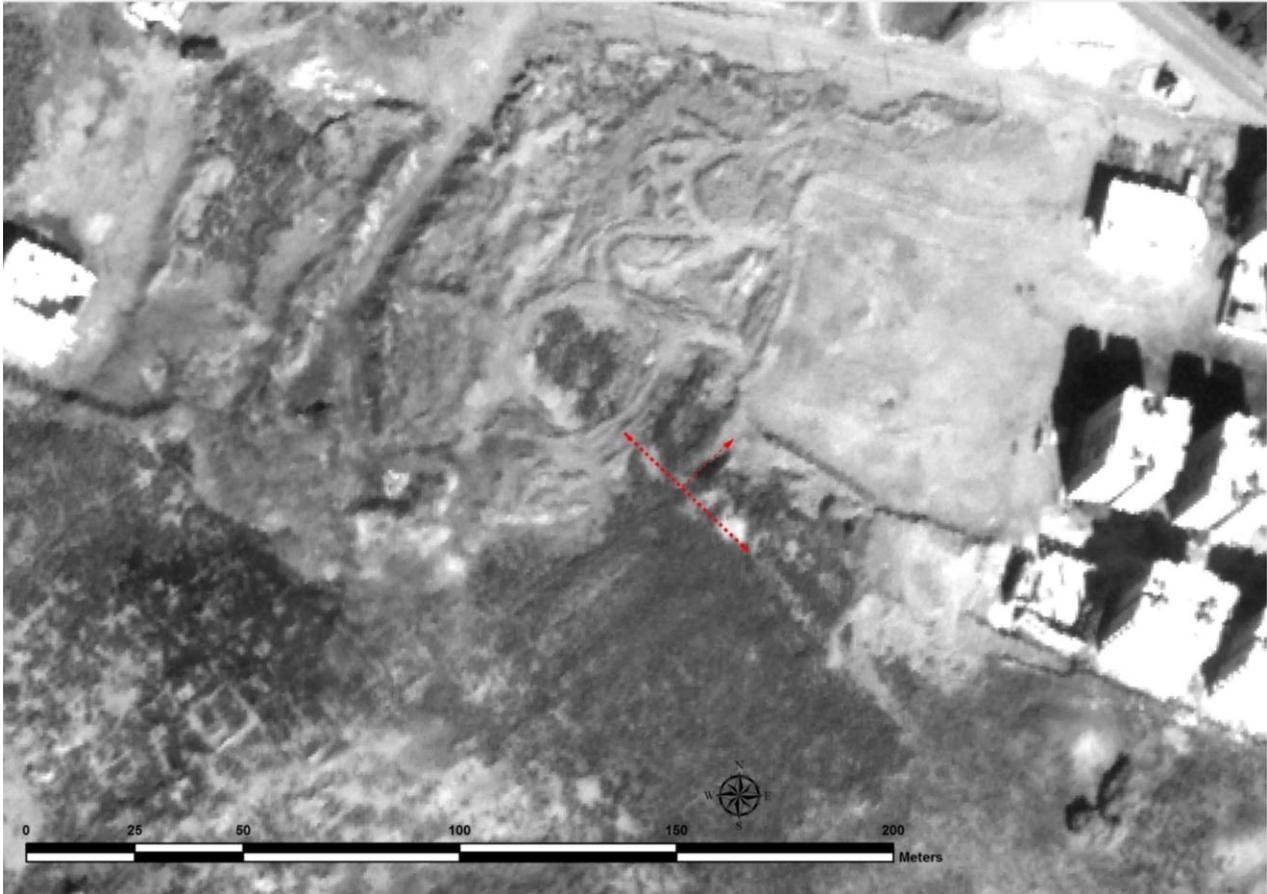
Figure 10. Shows the possible intersection of the S10-1 (pointing NE) aqueduct and the hypothesized main aqueduct (pointing NW/SE).

2. The S10-1 aqueduct flows northeast based on the slop of the floor.
3. The S10-1 aqueduct runs perpendicular to a crop line (previously assumed to be a road) visible in satellite imagery. This crop mark line may represent a main water line and the S10-1 aqueduct may represent a lateral line branching off the main line (Figure 10).

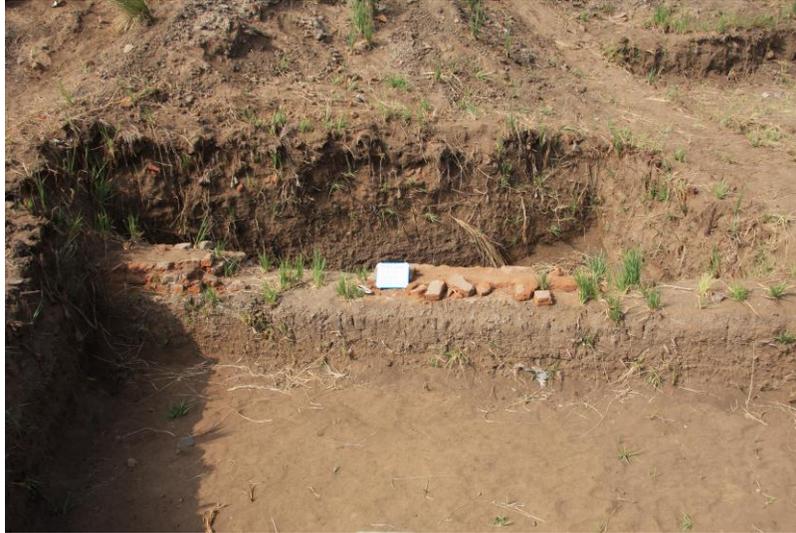
Figure 11. An example of one of the red brick linear structures mapped in 2010 from Unit P7-11.

4. The line also transects a series of linear brick constructions associated with large platforms and columns of red brick in salvage Grid P7 excavated by Mr. Hamdy Mashal and mapped by the University of Hawaii project. Previous to this analysis the function of these brick alignments could not be discerned (Figure 11 and 12).
