Excavations at Tell Timai 2012

University of Hawaii

December 1 to 27, 2012

APPENDIX II
SALVAGE EXCAVATION REPORT S10-1

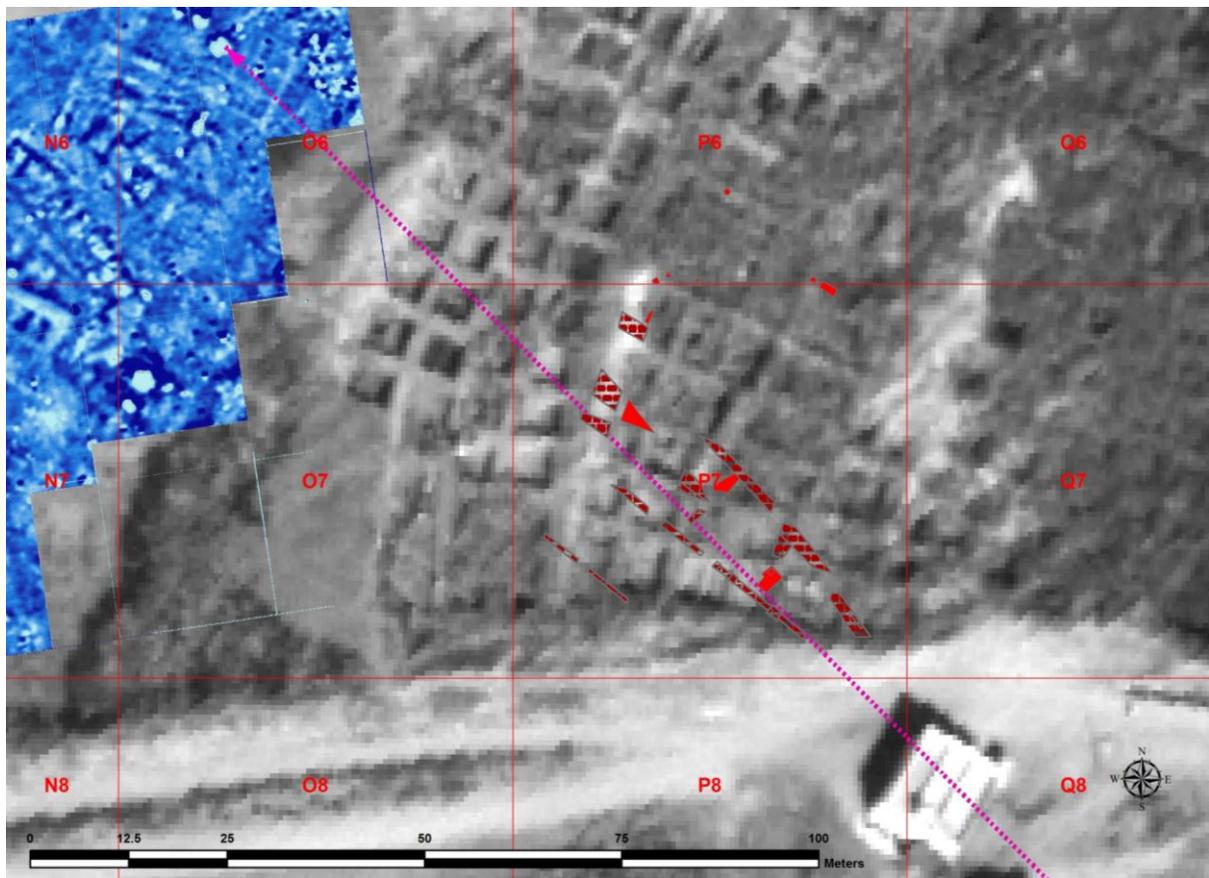
Figure 12. Prolongation of the hypothesized main aqueduct (magenta Arrow) through the north salvage area to the large well uncovered in Grid O6. Note that the prolongation aligns with the linear brick structures (red) mapped in the salvage Grid P7.

4. The line also transects a series of linear brick constructions associated with large platforms and columns of red brick in salvage Grid P7 excavated by Mr. Hamdy Mashal and mapped by the University of Hawaii project. Previous to this analysis the function of these brick alignments could not be discerned (Figure 11 and 12).

- The hypothesized main aqueduct line runs directly northwest to the large well in Grid O6 first identified in the 2010 magnetometry imaging made by Tomaz Herbich (Figure 13) with the University of Hawaii project and excavated in 2012 by Dr. Saad and Mr. Yasser Elgamel. The large well has been modelled as a large scale water well that would lift water in large amounts (Figure 12).

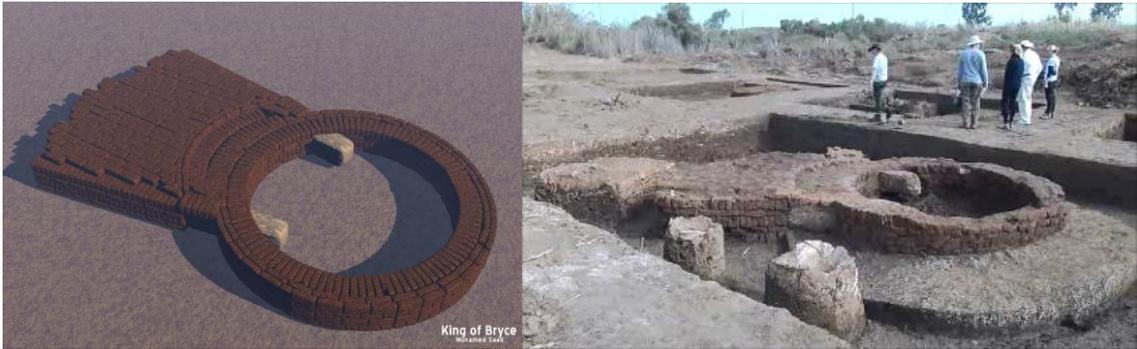
Figure 13. A CAD model of the well structure created by Mohamed Saad and a photograph of the same well in salvage Grid O6. (view northeast).

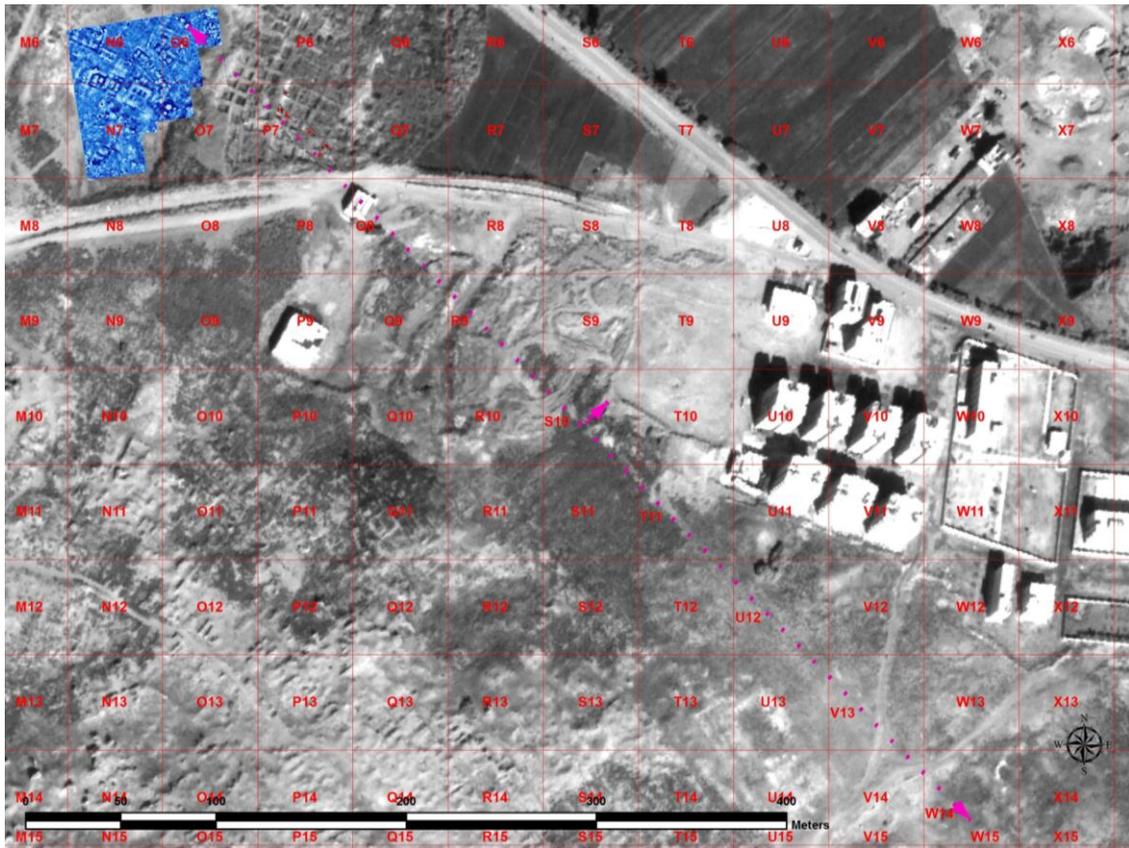
Figure 14. Line of the hypothesized main aqueduct running between well in Grid O6 and the baths in Grid W14.

- The line of the hypothesized aqueduct also runs directly southeast from the large well in Grid O6 to the area believed to contain extensive baths in Grid W14 (Figure 13 and 14).
