# **Excavations at Tell Timai 2013**

## **University of Hawaii**

### **May 14 to July 12, 2013**

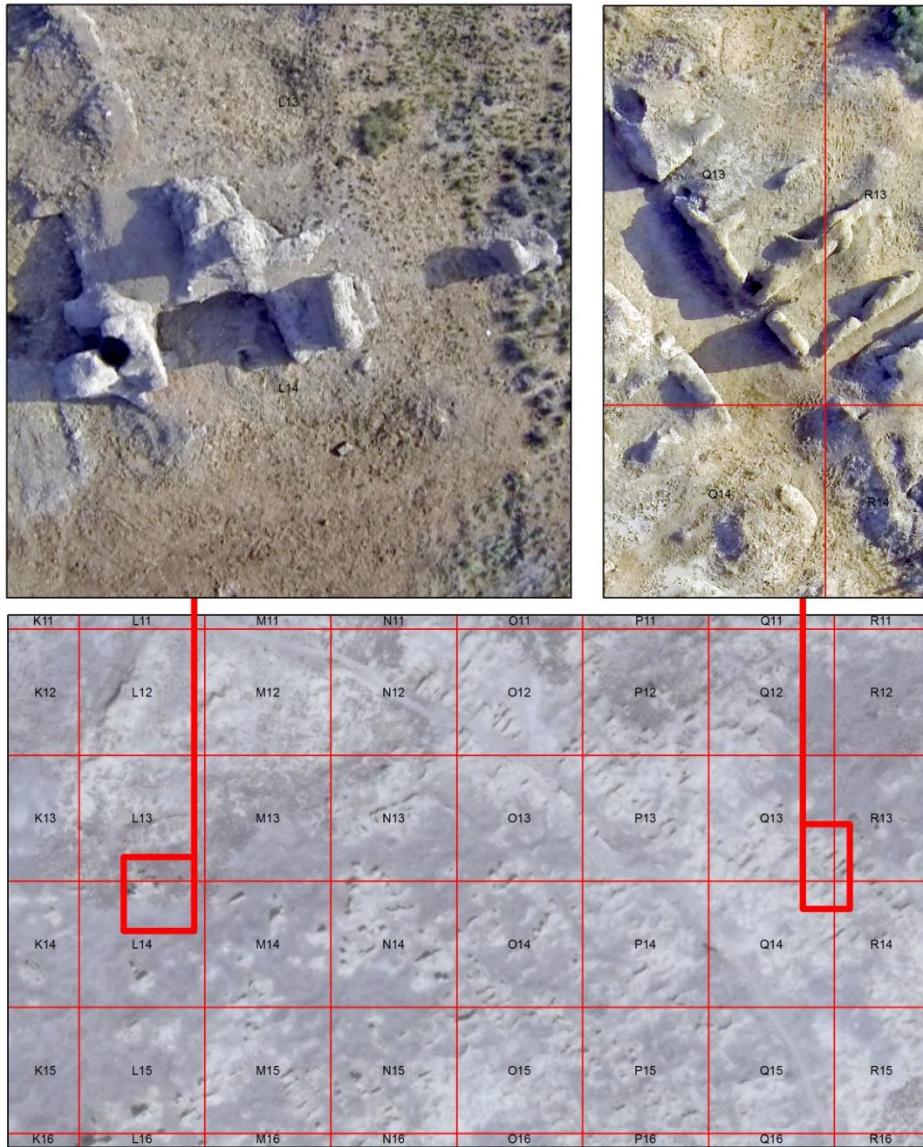
### Tell Timai 2013 - Areas for conservation (before)

Maps of areas where wall consolidation was completed.

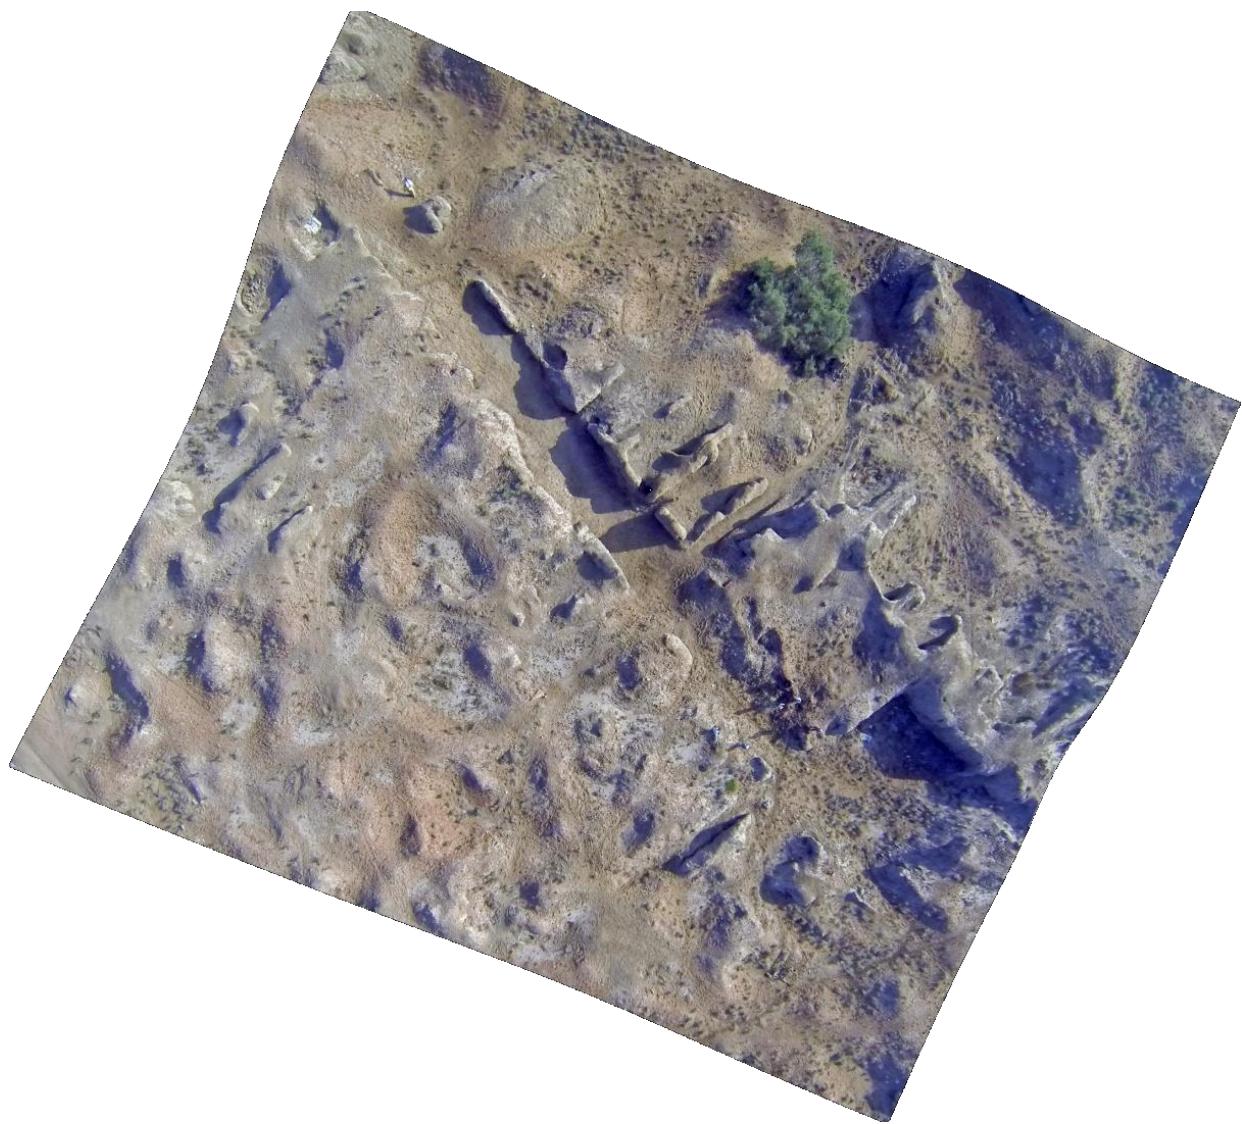
**Aerial View of Street # (The orientation of the Street #1 is Northwest-Southeast).**

This report analyzes the condition of the mudbrick architecture in the units Q13, Q14 and R 14 (the SW corner of the unit is in Q14 so the reference grid unit used is Q14), officially known as Street #1 . The street includes a collection of structures on both sides, probably residential units, whose last phase dates to the Late Roman Period. The site is located in the central part of the tell and is one of the best-preserved areas of Thmuis. The preserved structures were likely built on building foundation dating back to the Hellenistic Period and the area is of particular relevance as a well preserved example of urban architecture in a Greaco-Roman settlement.

Three insulae flanked the street on the south, west and east sides where additional street systems expand east. The buildings have been all compromised by the deterioration and collapse of mudbricks. The condition of the street is quickly deteriorating due to a variety of issues. All the buildings are constructed of mudbricks. In the condition assessment three walls particularly stood out as they were in dire need of consolidation: Structure #1 (S1) Wall 1 (W1) and Wall 2 (W2), Structure #2 (S2) Wall 1 (W1) and structure #7(S7) Wall 1 (W1). These walls have been badly damaged and if not consolidated they would have collapsed in a short period of time.

The lower portions of the structures are constructed of mudbrick measuring 25 x 16 x 13 cm whereas the upper part of the standing structures have been built with bricks measuring 25x 12.5 x10 cm. Mainly the damage consists of erosion of the lower portion of the wall, undermining of walls by dogs, insect damage in the wall fabric and deterioration of mudbrick due to natural causes (wind). One of the standing walls (S1W2) has extensive damage due to wasp nests. This increases exponentially the dangers to the structure as the holes dug into the walls by the wasps have weakened the mudbrick structural integrity and the overall wall fabric. Crumbling mudbricks and mortar loss has affected the integrity of all the structures. This loss of material has led to the failure of larger parts of the walls in upper and lower portions.

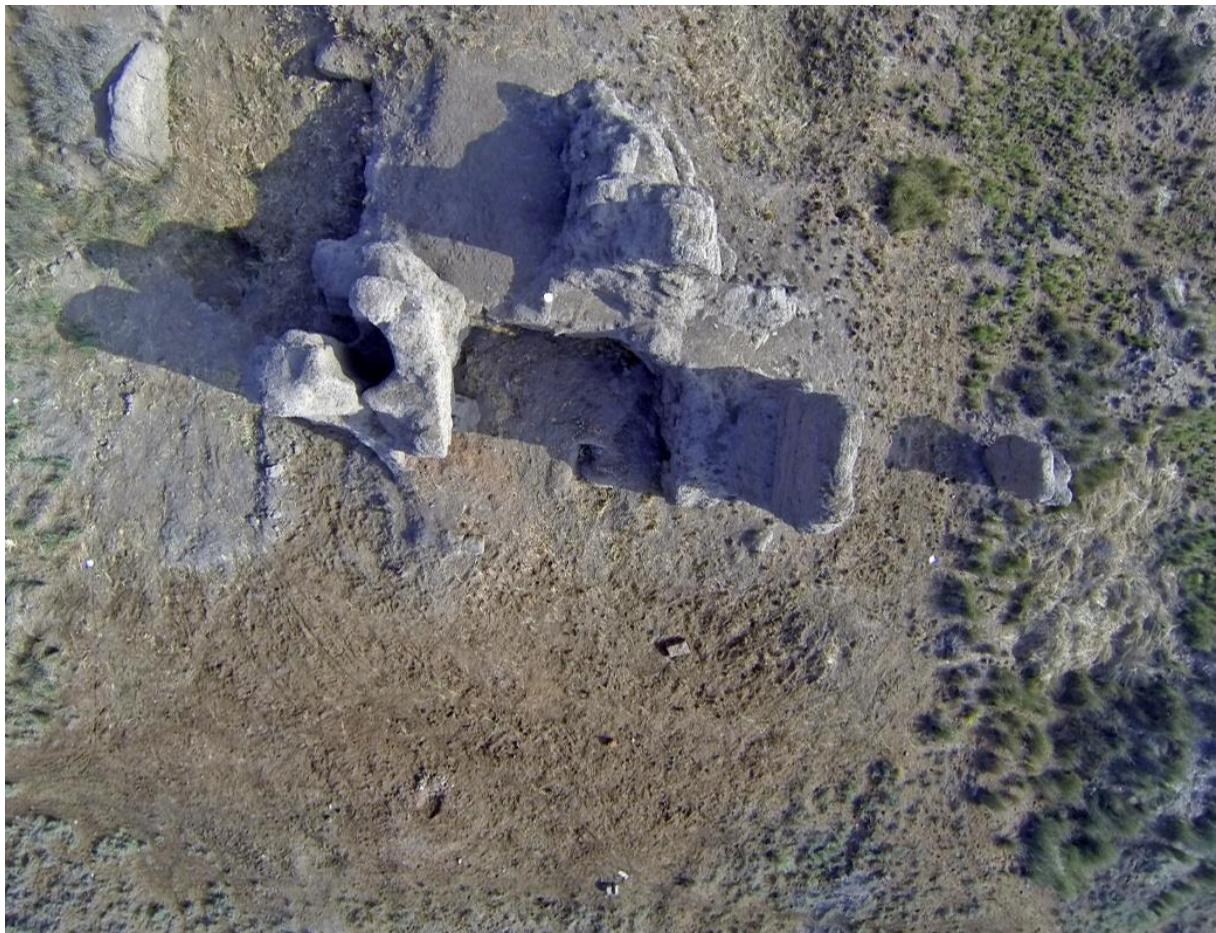
**Overhead View of the Building #1 (The orientation of the Building #1 is North-South).**

Building #1 is constructed of mudbrick with a wall thickness that can measure up to 5m. Crumbling of the bricks is clearly visible around the building and the mortar has deteriorated throughout the different façades, particularly to Wall #1 and Wall #3. This loss of material has led to the mudbrick failure along the lower portion of the walls and the highest part of the NE wall (Wall #1).

The standing portion of the architecture shows a two and possibly three storey building with multiple openings and a complex staircase system for access to the upper floors . This supposition has been made focusing on the actual preserved high of the building (12m), the mudbrick size on the lower and higher part of the walls, the walls' thickness, the presence of spiral staircases in the Southeast corner (Wall#4) and the beam holes.

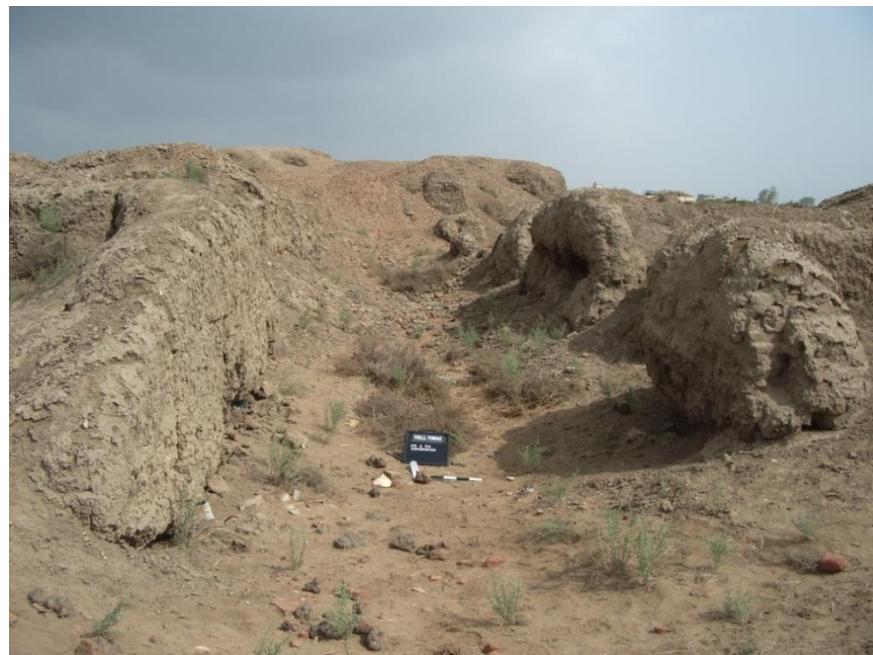
**Q 14, Street #1 Before Intervention**

In both areas the main issue was to preserve the structures for future excavation as well as to stop the rapid decay due to animal interaction and natural erosion of the walls. Four walls in Q14 and three in L14 have been badly damaged and if not consolidated they would have collapsed in a short period of time. To preserve this area we have used the following methods:

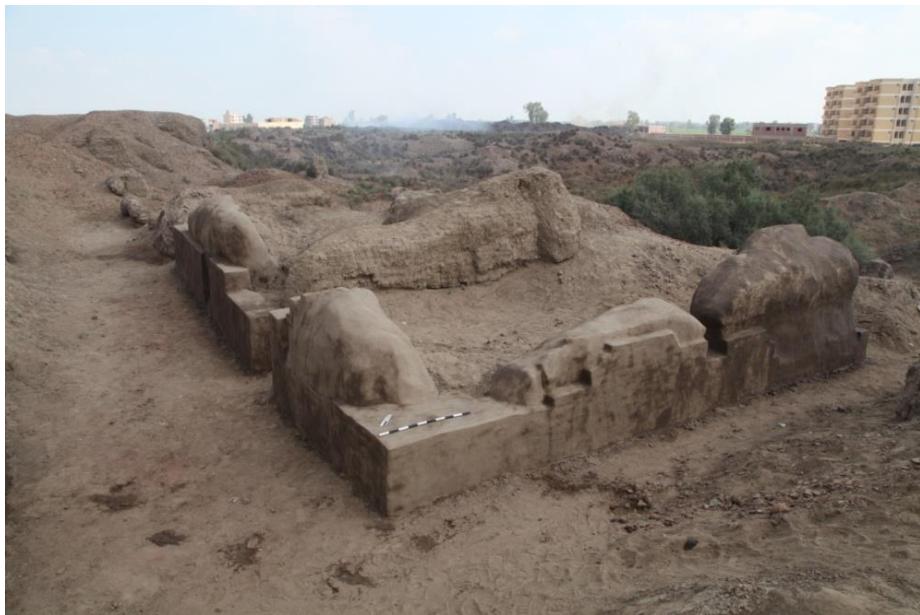
**Q 14, Street #1, After Intervention.**

1) Reconstructing damaged parts of original mud-brick walls by using new mud-bricks to stop the spalling and to counteract the soil pressures. We made it clear where we had interfered using red oxide into the new mudbrick so their red colour differentiate them from the original archaeological data.

3) Consolidation by injection: Cracks and holes inside walls were injected with traditional mortar, either by using syringes or manually.

4) Plastering with traditional mortar: this method is the most used in preserving old mud buildings since ancient times. Plastering parts of original mud walls, especially deteriorated ones, and the new supporting walls, with a mixture of traditional mortar was used to improve and strengthen the original mortar. The shortcomings of this method, erecting supporting walls and using traditional plaster, is that it hides or distorts the original facades and decorative features. All the interventions are reversible and preserve the integrity and the authenticity of the walls.

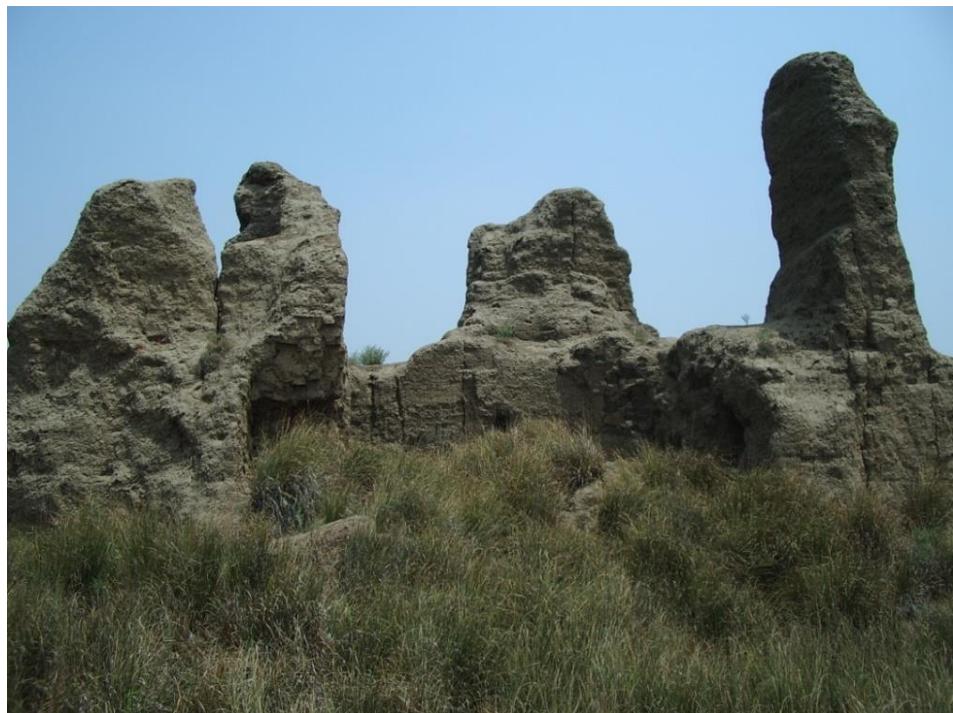
**L14, Building #1, Before Intervention.**

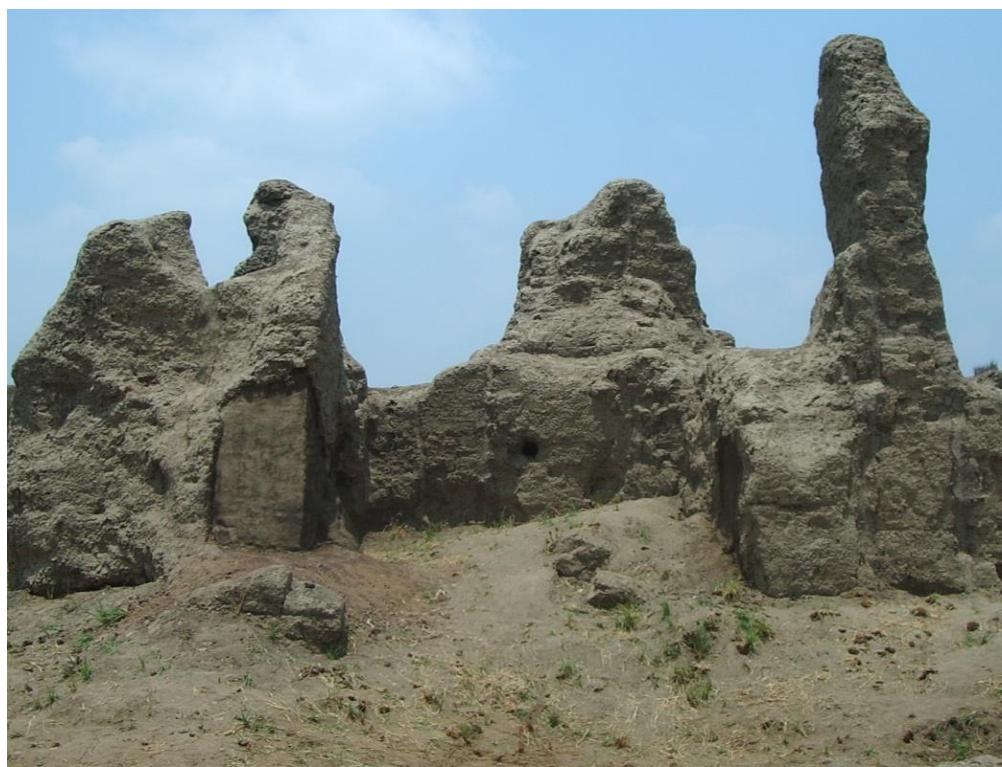
**L14, Building #1, After Intervention.**

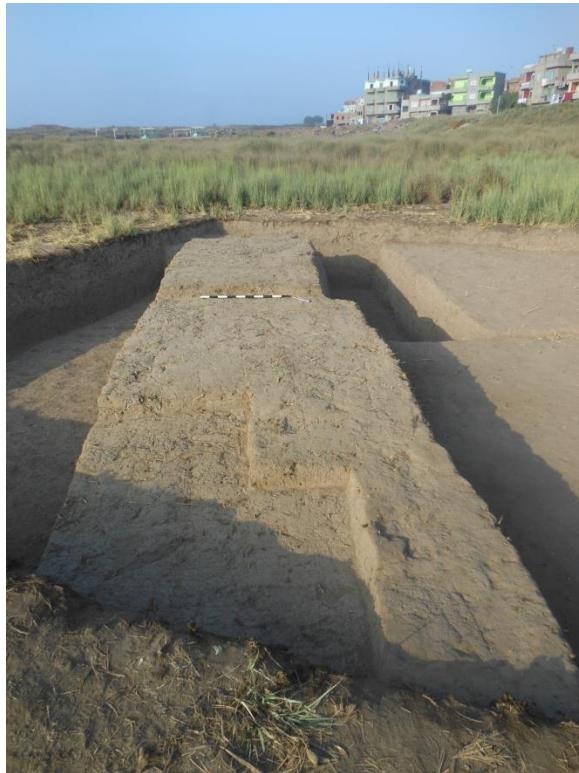
**View of the crenellated wall looking south**

L6-1 was placed following a magnetometry anomaly which indicated the presence of a large architectural feature. Excavations revealed a large area of modern rubbish and mudbrickdebitage (F001) overlying a long wall running north south. However, due to the denuded nature of the mudbrick and the heavy damage from modern activity, part of the east-west continuation was inadvertently removed as part of Feature 001 and was only found in the baulk after the mudbrick had dried, and cracking appeared in the mortar lines, (refer to the SE-NE baulk drawing). The wall (F008) was shown at its minimum width of preservation to be about 2.2m wide. The wall on its western side exhibited crenellation which is typical of religious architecture on temple walls of the period from the New Kingdom onwards. This crenulation defined the western side as outside of the structure. To the west of the wall (F002) there was a large mass of collapsed mudbricks which were almost devoid of any archaeological material, apart from a few worn sherds of pottery. Feature 002 was stopped when pottery quantities increased and it was also noted that F002 had extended down past the wall base by approximately 10 cm. There was no foundation cut found for the wall, and no sand present which is common for foundations of temple walls. It appears at that this structure lacked foundation trenches and instead was founded on a very thick fill layer and build up on top of that. It was deemed necessary to conduct a sondage down against the side of the wall. This sondage (F005) comprised large amounts of pottery, including Late Period (4<sup>th</sup> Century B.C.) pottery which included globular jars and small perfume bottles. This fill probably extended underneath the wall (F008); however, the wall was retained and so this cannot be said for sure until the wall can be removed in a future season. The final deposit in the sondage was defined by a break in the pottery and then a sudden revival in the pottery quantities. This deposit had a Hellenistic character to it suggesting that the fill used for the construction of the wall was brought in from elsewhere and separate dumps of Late Period and Hellenistic ceramics were used to form the thick fill layers for the wall.

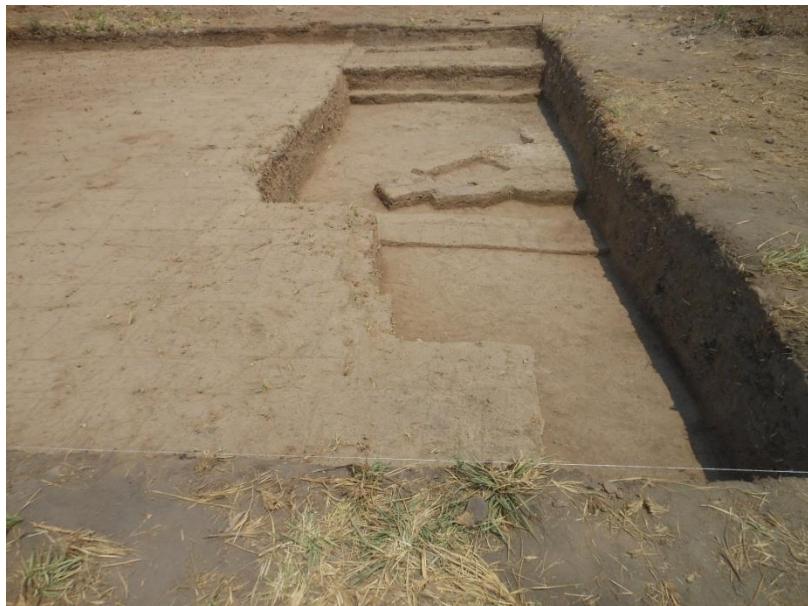
**A view of the mudbrick floor and internal structures and foundations.**

There are chisel marks on most of the stone remnants suggesting that the structure was purposefully town down and removed. All this information suggests that a high status building once stood in this area. Many of the fragments were of grandiorite, limestone, and black granite and some grandiorite pieces indicate smoothing and working that may indicates they are part of a destroyed statue. The destruction is highlighted by the presence of many of the stones found embedded into the hard packed limestone floor including many of the chippings. The floor had a coin in it which is waiting analysis and dating. The floor was then followed by the cutting of the floor by the walls that probably formed part of the mudbrick architecture seen across the area in this seasons's excavations, as some of the walls are built up on the stone destruction and lime floor, while under some of the bricks nothing is found but another fill layer.

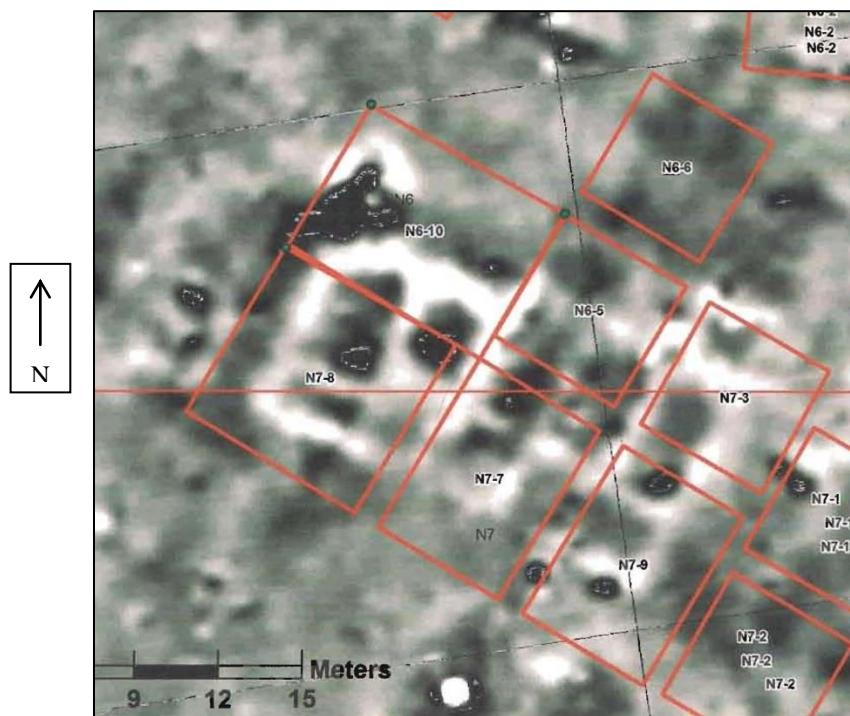
Magnetometer results and the location of units N7-3, N6-5, N7-7, N7-8, N7-9, and N6-10. After the units were excavated to expose the building's walls, the balks between the units were removed to show the entire building. Afterwards, overhead photographs were taken of the building.

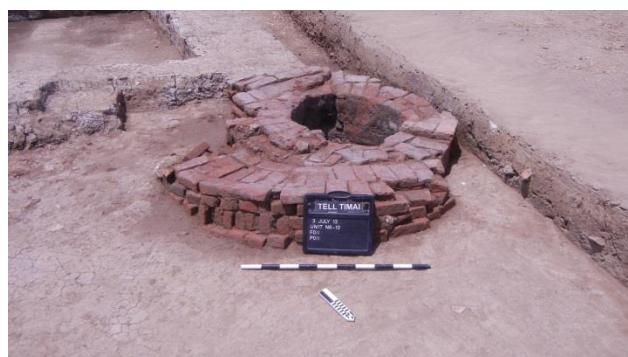
**Well located outside the NE corner of the Hellenistic building.**

Another notable find was a well outside the northeast corner of the Hellenistic building. It was made of fired (red) bricks held together by a mud or clay mortar. Part of the northeast corner wall of the Hellenistic building was removed to build the well as if to use the wall as a support. The contents of the well were removed to a depth of 1.45m before work had to stop because of a high water table. Inside the well was found four muktafs of pottery, one muktaf of stones, mostly limestone, and many animal bones. The pottery is Late Roman (third to fifth centuries A.D.). The dating of the pottery and the fact that the well cut into the walls of the Hellenistic building suggest that it post-dates the building. The mud/clay mortar used to bind the bricks suggests a Hellenistic construction, because Romans probably would have used cement mortar; however, the building is believed to have been destroyed during the second century B.C. and it is unlikely that the well remained in use for another 300-500 years. The actual dating of the well will have to wait for a future season when its exterior and interior are further excavated.

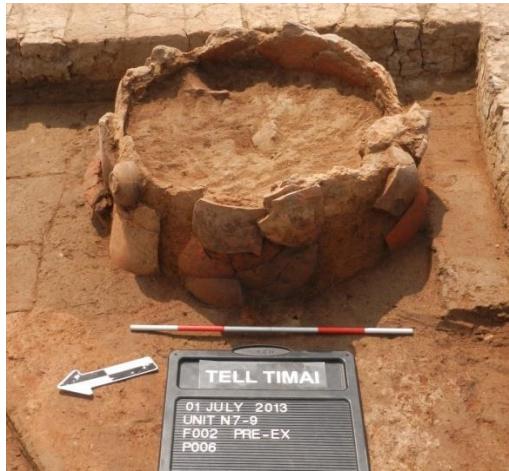
**N7-9 Oven in situ.**

Unit N7-9 was a 5x8 meter unit concentrated on the southeast corner of the building. Almost immediately the main walls of the structure were uncovered, 5cm below the surface. At the same level, the top of a relatively large ceramic oven was discovered in the northeast part of the unit. The oven was later discovered to have been built into a mudbrick platform, rather like a work bench.

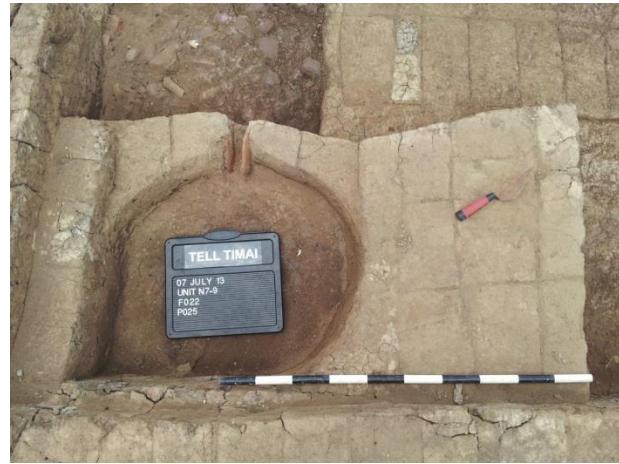
**Mudbrick structure made for the oven.**

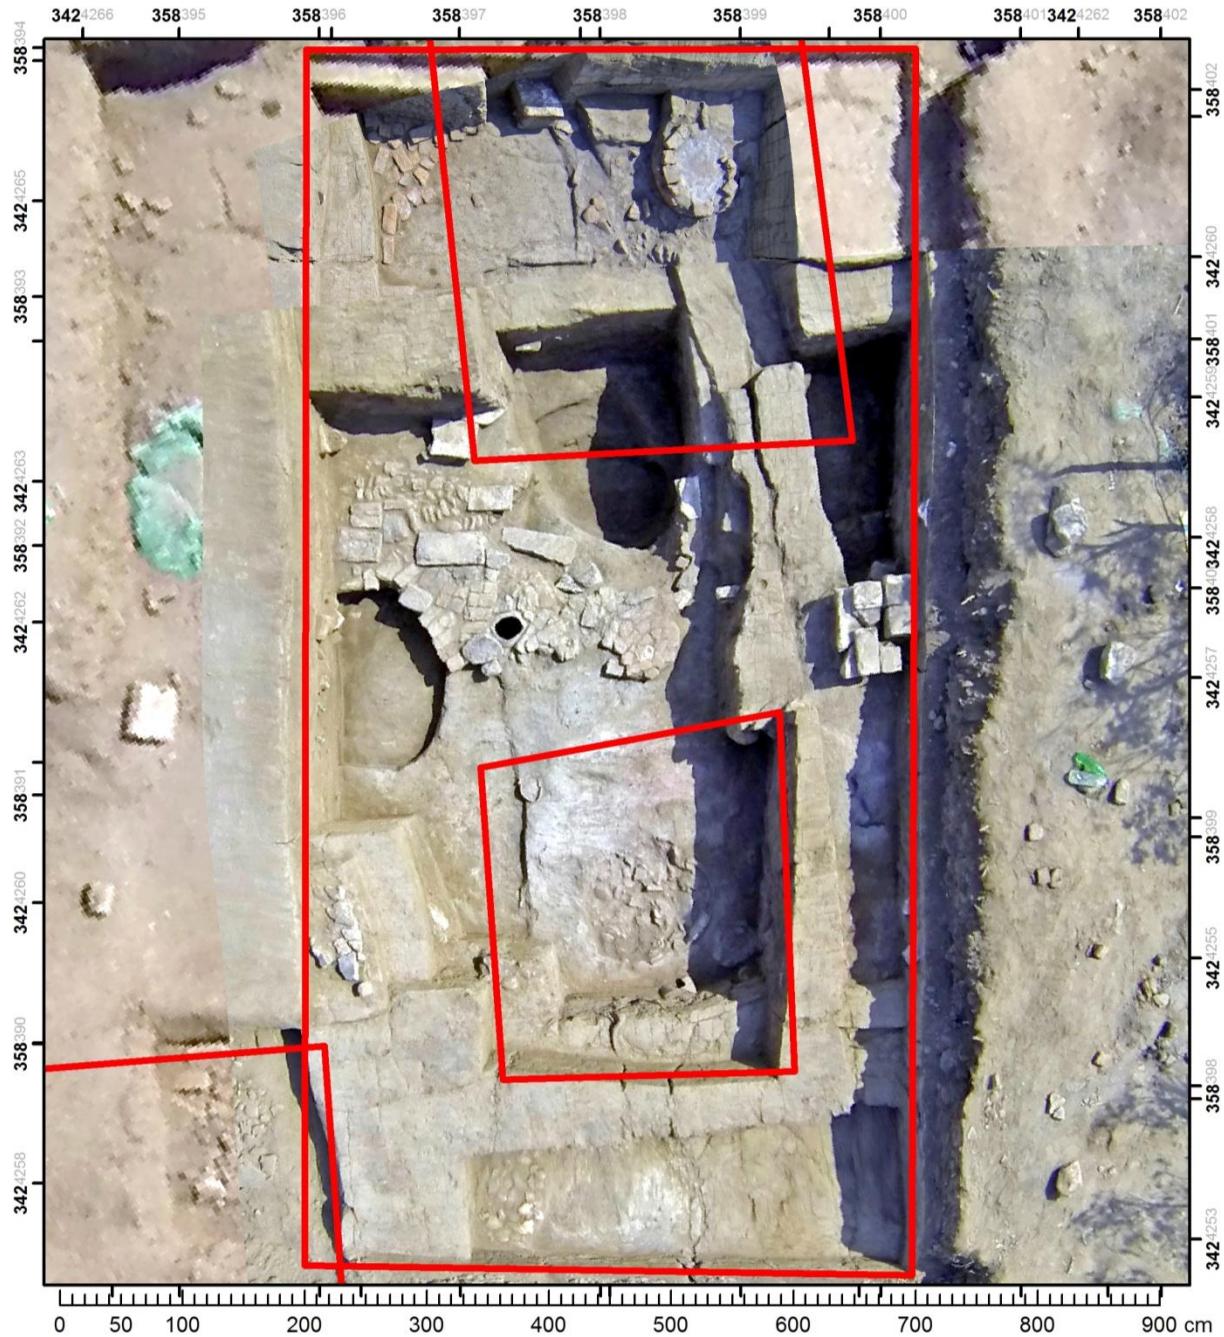
Aerial photogrammetry  
Scale 1:50  
IHB  
10JUL2013

**Overhead view of the unit with previous excavations outlined in red.**

Phase II: This phase is represented by walls 006 and 060 in the southern part of the unit, which are approximately 1.1 meters of width, built with consistently proportional bricks (in contrast to the later walls of Phase I). At least two surfaces are associated with 060, and were found in the very south of the unit, and continued into the baulk. As the focus of the excavation was on the paving stones mentioned above (in the center of the unit) and these surfaces lie on the other end of the unit, it was decided not to excavate them in order to preserve them for possible future excavations to the south. The fill that contained the bowl mentioned above is perhaps contemporary with or later than these walls, and the fills associated with these walls contained pottery types that range in usage from the 1<sup>st</sup> century BC through the 1<sup>st</sup> century AD. Further, and most notably, a saucer lamp likely to be of early Roman type was found *in situ* stuck into the bottom of the wall, above the mudbrick floor (F063), which, in addition to giving a date for the use of this wall, also gives a sense of how these saucer lamps might have been used. The structure represented by this building appears to date to the early Roman, or possibly late Hellenistic.

Phase III: Phase 3 is represented by the pavement/floor (F050) that includes the 3 fine paving stones that were first observed in the looter hole. Exposure of this surface reveals that the paving stones in question (and the others found) are in reuse: the floor is a haphazard mix of paving stones of various sizes and bricks. The size and quality of the paving stones, and the haphazard nature of their placement, suggests that these paving stones had been robbed out from a finer, more monumental building and reused. F050 has been cut both in antiquity and modern times, so no relationship with walls is preserved in its northern, eastern, or southern limits. F050 continues into the western baulk – extension of the unit in that direction might possibly pick up an associated wall, but this is purely speculative. The date of this floor is indeterminate at this time. As for its purpose, the construction style is appropriate for floors and especially courtyards of domestic structures or workshops.

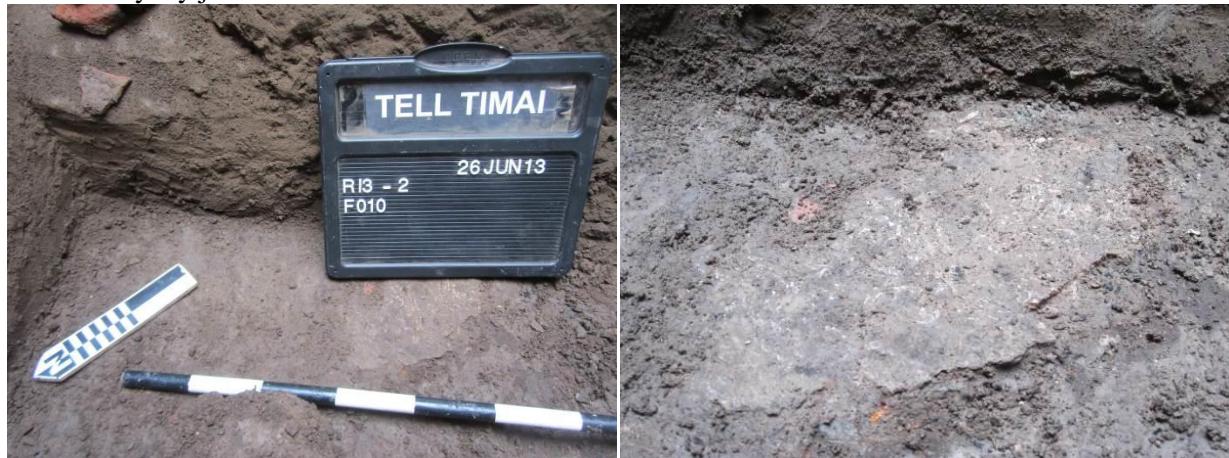
**The fragment of floor surface (F010) and close up.**

material in which the fragment was made appeared to be some sort of mixture between mortar and stone fragments. Two relatively broken vessels were encountered in proximity to floor F010 but it was found out that they lay just below the floor surface level and had no direct connection to it.

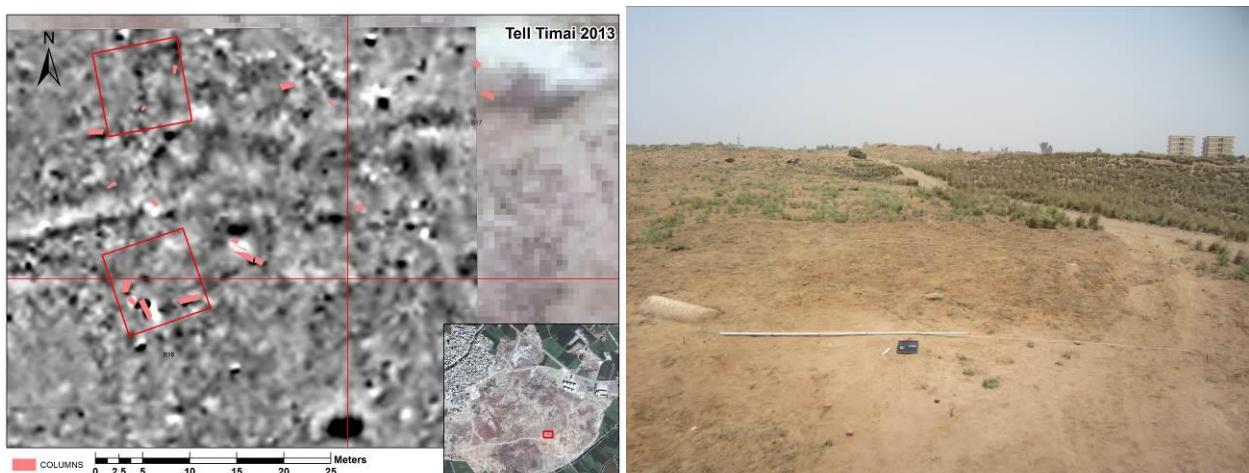
**The results of the magnetometry survey and the two units R17-1 (upper) and R18-1 (lower) (Left). View of the unit before excavation (Right).**

The area where unit R17-1 was opened is located in the southern part of the Tell, a zone of lower elevation with respect to the central area of the site. It is crossed by modern roads that are used daily by the local inhabitants of the nearby villages and therefore presents no visible architectural features except for a series of Aswan pink granite columns and blocks that scatter towards the north eastern part of the Tell. The initial interest in this sector had been triggered by the presence of the granite columns. The positioning of R17-1 was influenced by the results obtained through a magnetometry survey carried out at the beginning of the mission. The 10 x 10 meter trench was located in the area where the magnetometer had detected a possible buried architectural corner and it also included within its boundaries two granite columns protruding from the ground surface. The unit's aim was to investigate the nature of the granite columns and their surroundings in comparison to results of the magnetometry survey and achieve a greater understanding of the history of use of this part of the Tell.

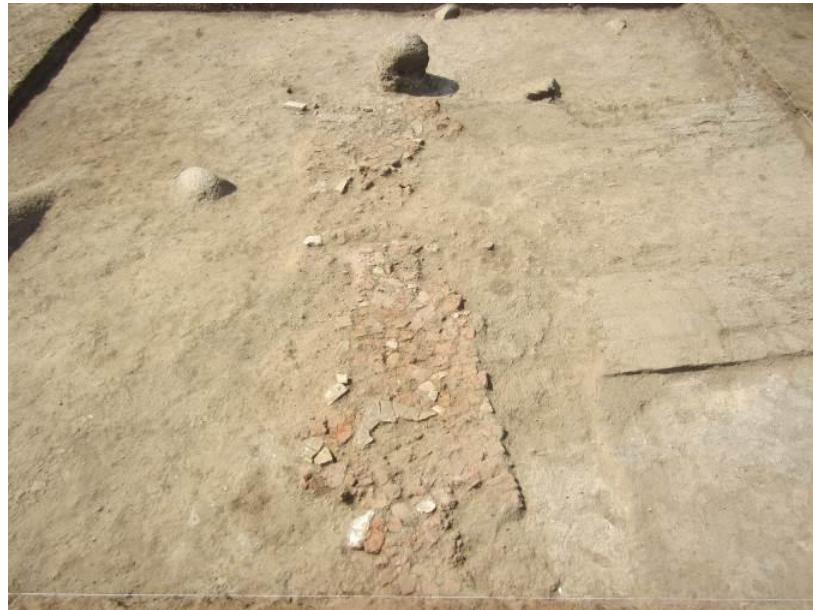
**F005, the fired brick and stone path.**

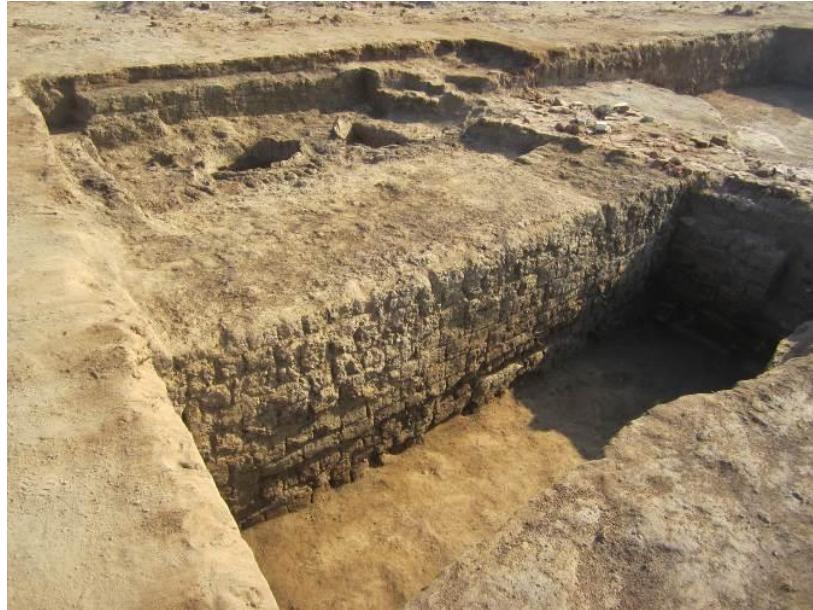
**The two overlaying walls F006 and F025.**

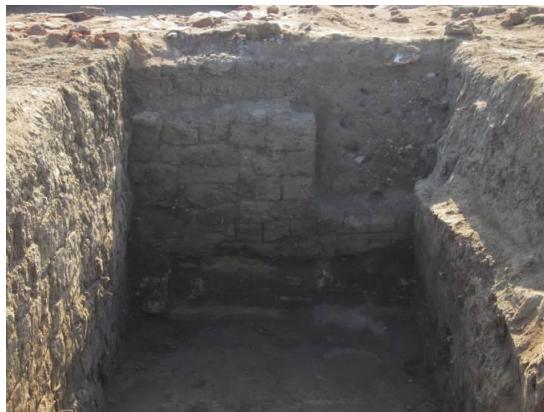
**The two overlapping walls F007 and F020.**

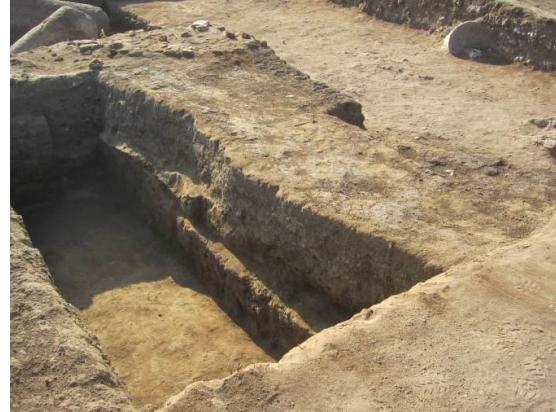
**The two overlapping walls F023 and F024.**

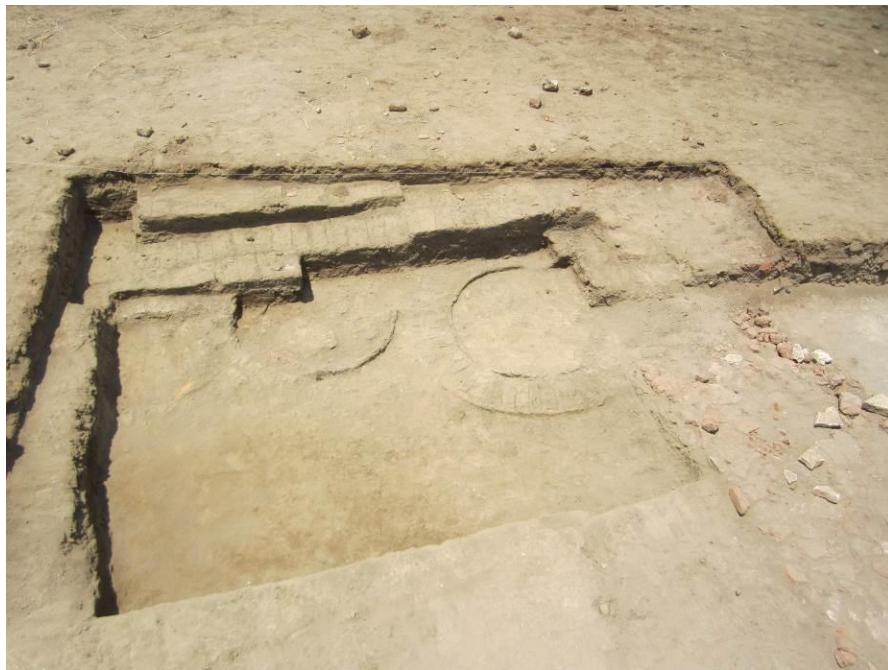
**F014, F015 and F016, the storage vessel containers (surrounded by walls F003 and F022).**

Below a layer of collapsed mudbricks runs another wall (F022) perpendicular to F003 and parallel to the clay containers. Despite the proximity, no connection between F003 and F022 was found. The latter appears to continue below the storage vessel containers but it was not possible to ascertain it due to the closing of the unit at the end of the season.

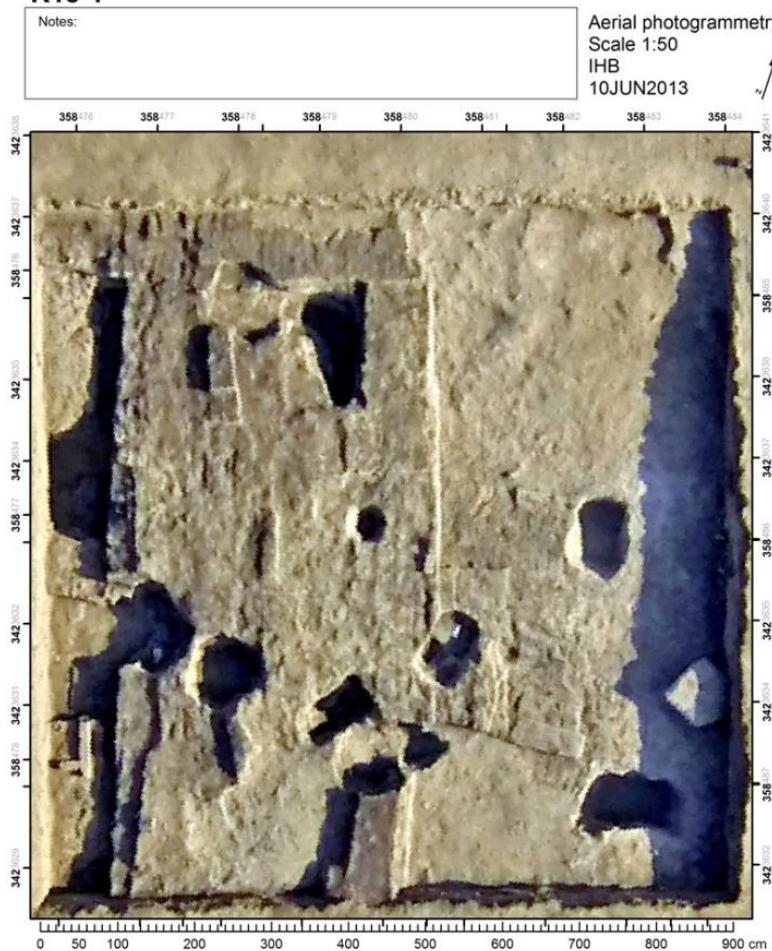
**Tell Timai 2013  
R18-1**

**R18-1 end of excavation blocks over magnetogram.**

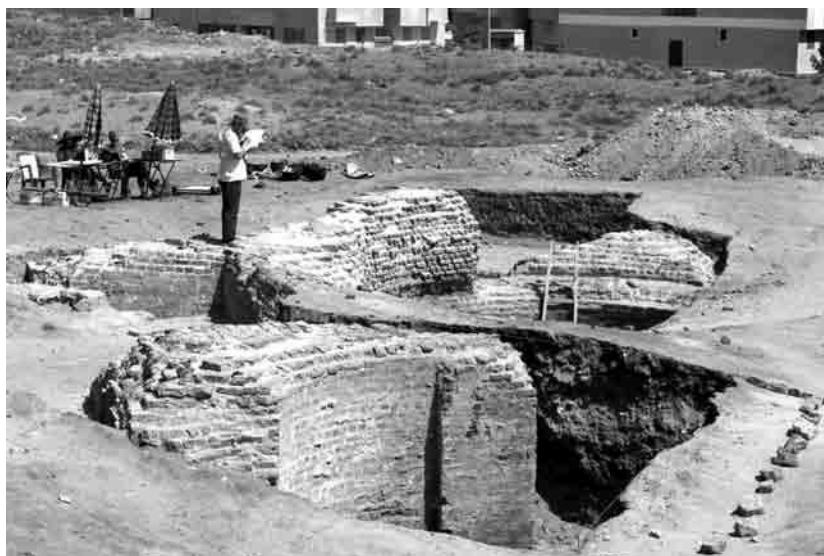
**Fig. 1. Unit 1 (southern view).**

1 m in width was detected alongside part of the foundations of the larger apse. Part of the lower silt layers located below the foundation level of the larger apse were also investigated in order to gain an understanding of the previous vocation of the area. Pottery sherds dating to the late Hellenistic period were recovered and a plaster floor was uncovered beneath two different layers of silt. The absence of Roman pottery may be a sign leveling, though further investigation would be needed in order to fully understand the occupational chronology of this zone.

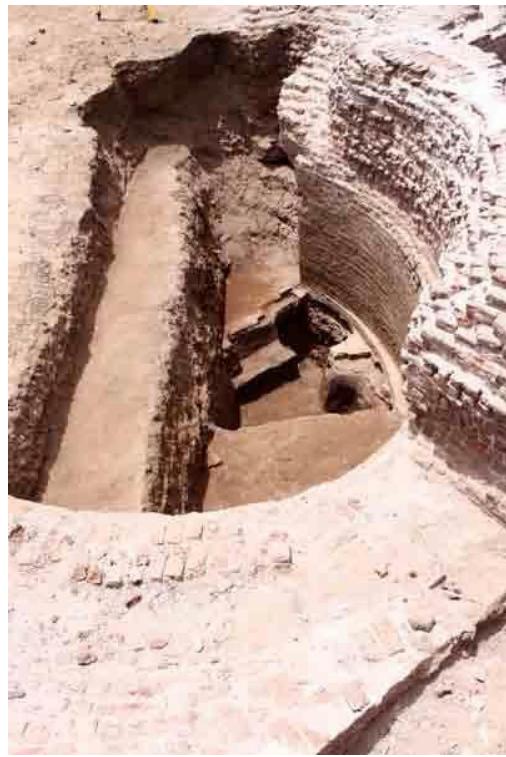
**Fig. 2. Unit 1: Interior of the larger hemicycle (northern view).**

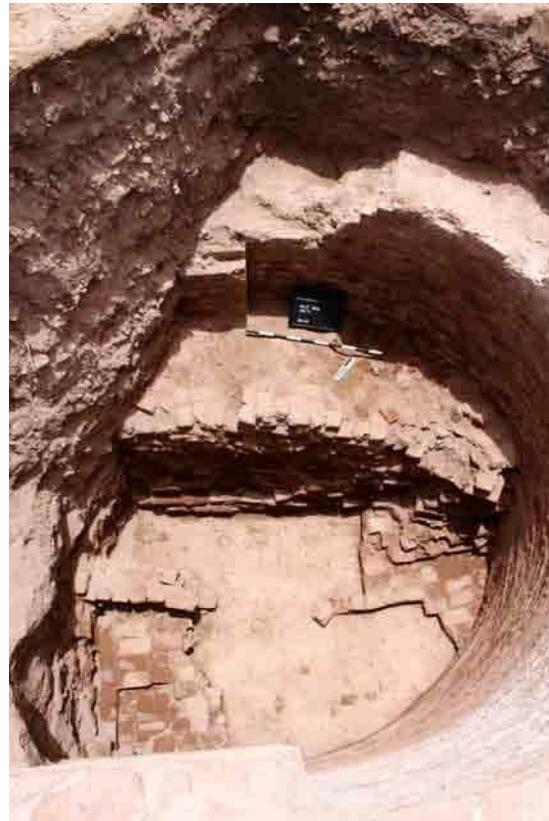
**Fig. 3. Unit 1: Interior of the smaller hemicycle.**

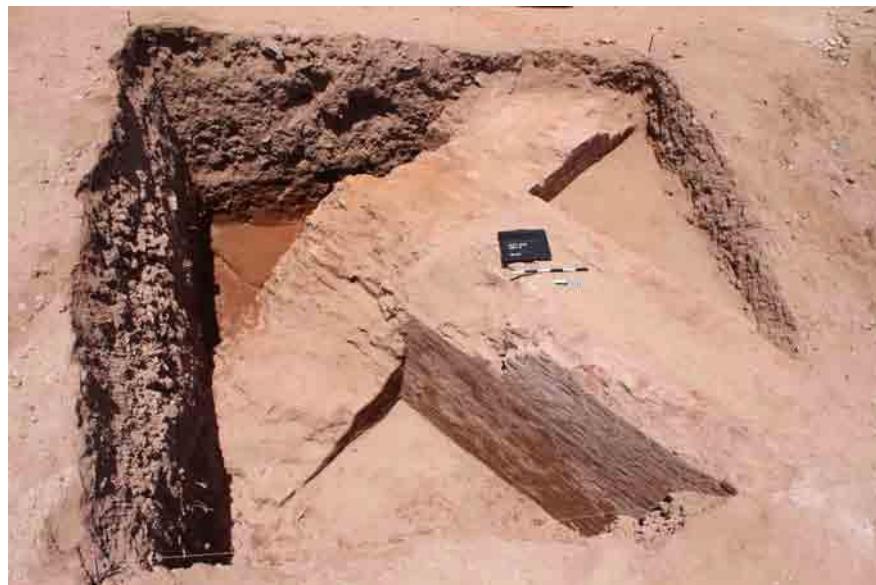
**Fig. 4. Unit 2.**

A second unit (this time of 5 m X 5 m) was opened east of Unit 1, in a zone where another redbrick cluster was visible from the surface. The cluster in question proved to be a T-shaped structure that corresponds to the continuation of the one uncovered in Unit 1. Although the excavation reached a depth of more than 4 meters, the foundation level of the wall could not be reached before the end of the season.

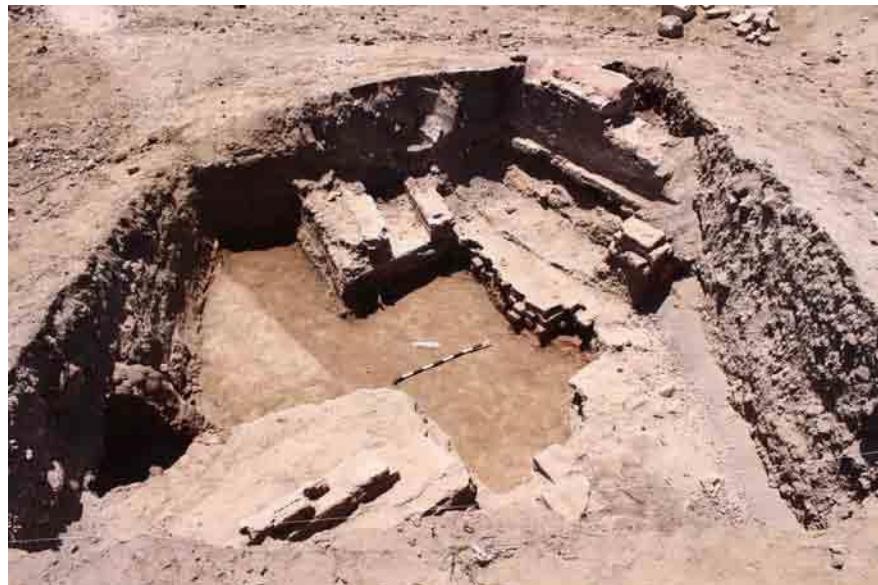
**Fig. 5. Unit 3.**

Unit 3 is located south of Unit 1. Its delimitation was justified by the presence of another protrusion of redbricks, whose alignment was architecturally coherent with the structure unearthed in Units 1 and 2. Yet although it is indeed a wall, it soon appeared to have no relation to the others: not only is the wall much thinner, but its foundations were reached after less than half a meter. A plaster floor was also found below the wall's foundations, but at a level too high to have any link to the other floors. Furthermore, a glass kiln was individuated and a mudbrick floor consisting of at least 4 visible rows of bricks emerged right below it. These structures, together with the more numerous material findings found in this unit, clearly state that this area was occupied in a later period than the structure unearthed in Units 1 and 2. The end of the excavation season prevented us from gaining a better understanding of this unit.

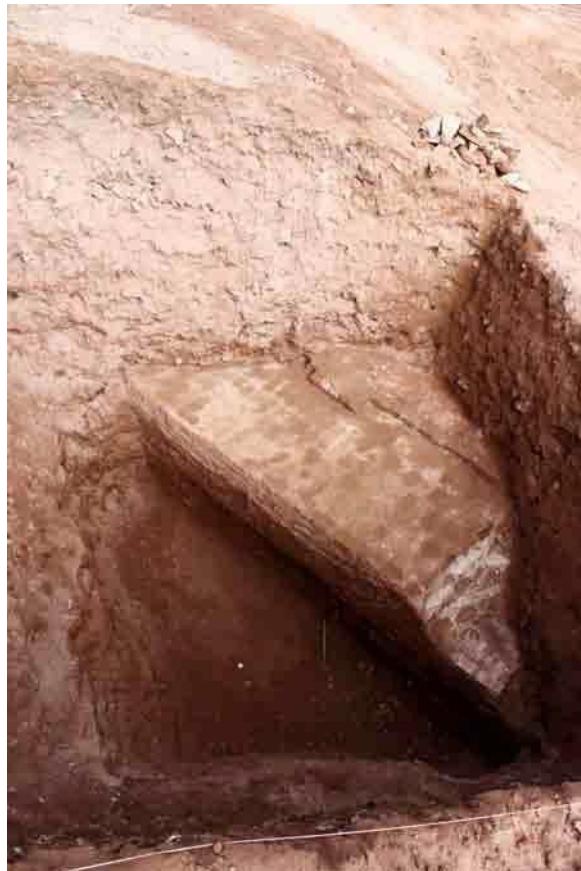
**Fig.6. Unit 4 (eastern view).**

The opening of Unit 4 aimed at illuminating the overall plan and limits of the building found in Units 1 and 2. Starting from the preliminary plan made by M. Van Peene (fig.8), an area located east of Unit 1 and south of Unit 2 was targeted. After the removal of c.3 m of filling, an architectural element (a wall or platform?) pertaining to the original structure was found and its foundations were reached. Given the depth at which it lied, it seems highly probably that it had been damaged and partially destroyed, possibly for the recollection of bricks.

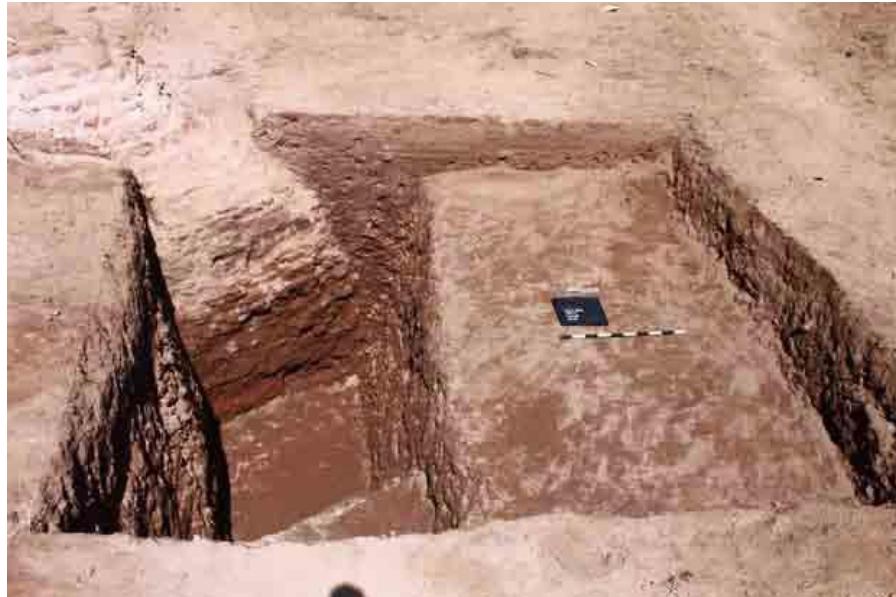
**Fig.7. Unit 5.**

Following a deep surface cleaning that revealed the northeastward continuation of the wall found in Unit 2, the opening of a fifth unit took place. This operation revealed that the wall quickly plunges. Given the severe disturbance the area has encountered, it is possible that, here too, what seems to be the end of the wall actually corresponds to a heavily destroyed part of the main structure. This is all the more probable since, although a depth inferior to that of the foundation levels found in Unit 1 was reached, the foundations of the wall have not yet been reached.
