# **Excavations at Tell Timai 2013**

## **University of Hawaii**

### **May 14 to July 12, 2013**

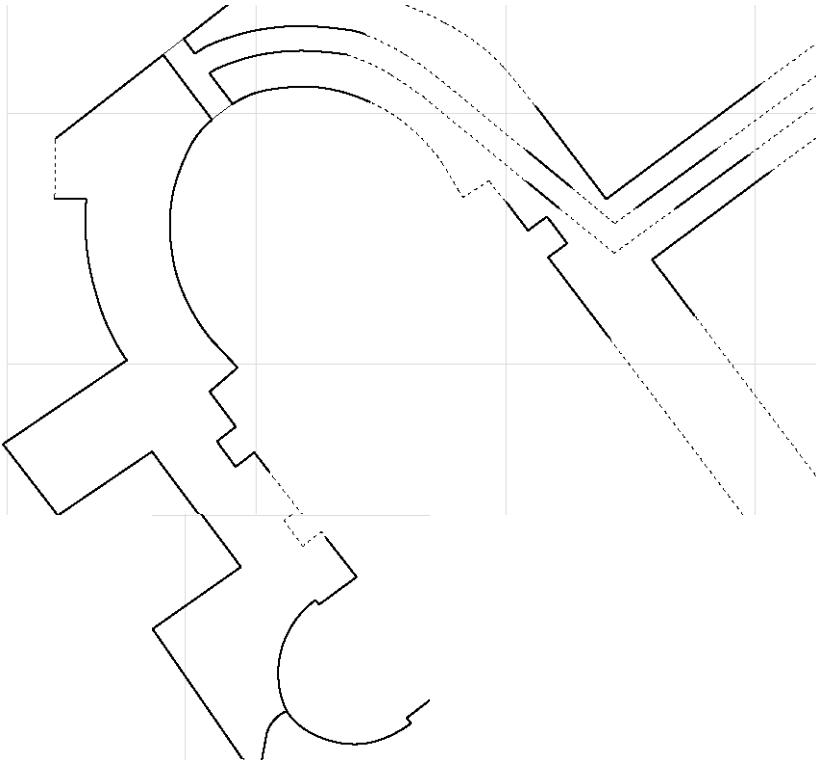
**Fig.8. Preliminary plan ofthe main structure (credits: M. Van Peene)**

The structure forms a rectangular room of c. 15-m long. It is prolonged in the northwest by an apse endowed with a bay in its axis and opens into a small apse in the southwest. The latter was covered with a cul-de-four vault. One also notes the presence of a passage in the masonry, which follows a very light slope from the beginning of the northeast wall to the axial bay. The function of the latter cannot be determined with any certainty. However, the presence of calcareous deposits on the surface suggests that it was submitted to water runoffs over a long period of time. The module (21 cm long, 10 cm wide and 5.5 cm thick) and the technique used to assemble the bricks (i.e. over abundance of lime mortar that forms 3 cm-thick joints on average) indicate a Late Roman dating. The building typology seems to exclude the hypothesis of a basilica or church, and would rather indicate a structure that belonged to a much larger ensemble. This is also suggested by the probable continuation of the north-east wall (Unit 2 and 5).
